Caltrans County Road 32A Diamond Grooving Experiment Sacramento, CA

Testing and Report Prepared by Larry Scofield

Draft Report

4/30/07

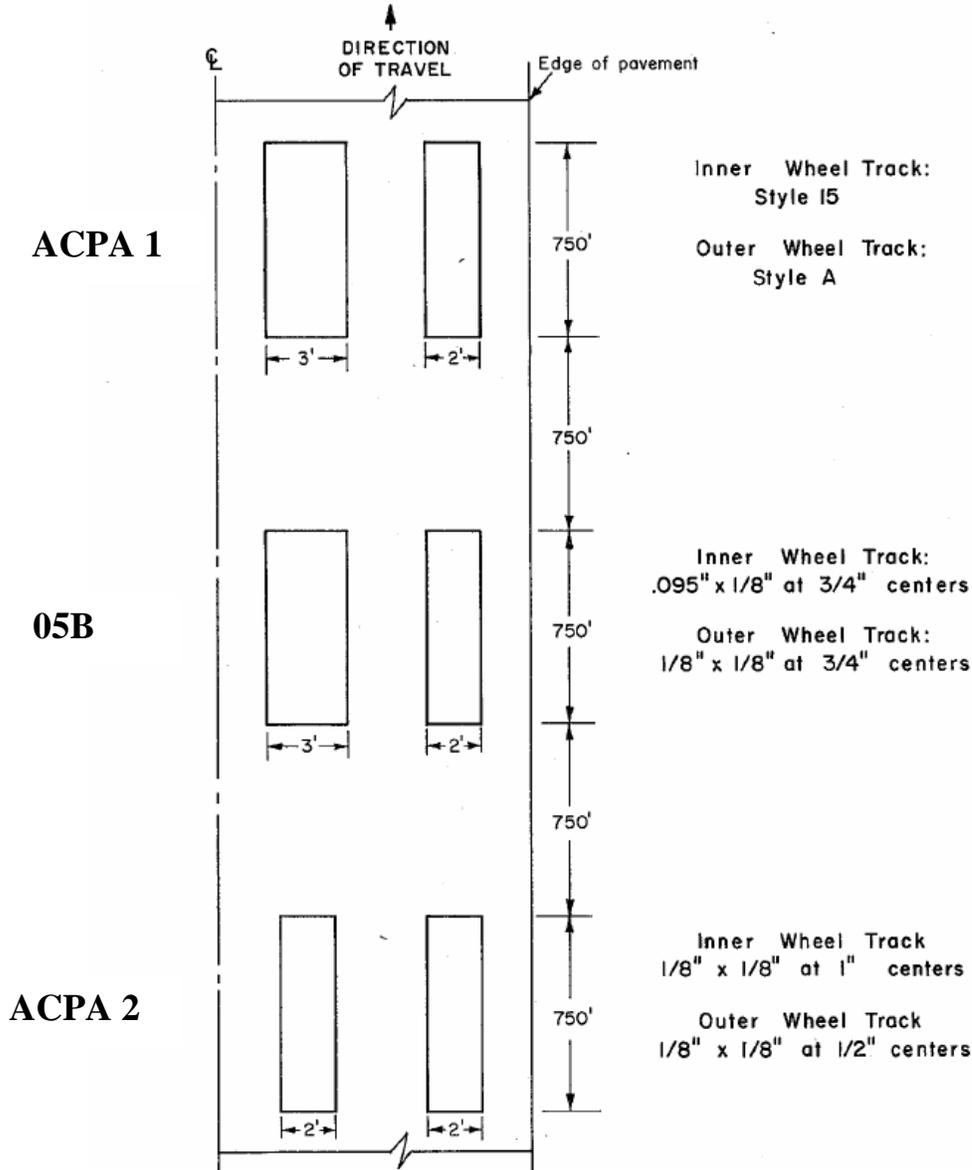
Figure 2 Original Construction Design and Layout¹

The original layout of these sites is shown in Figure 2 which is from the 1969 report¹. As evident, each of the sections is 750 in length and separated by 750 ft. The section designations used for the current ACPA OBSI testing are shown on the left of Figure 2 and the original section descriptions are shown on the right. Except for ACPA 2, the left wheelpaths are typically grooved 3 ft wide and the right wheelpaths are grooved 2 ft wide. No explanation as to why the difference in wheelpath groove widths is provided in the 1969 report. For ACPA Site 2, both wheelpaths are approximately the same 2 ft wide groove pattern.

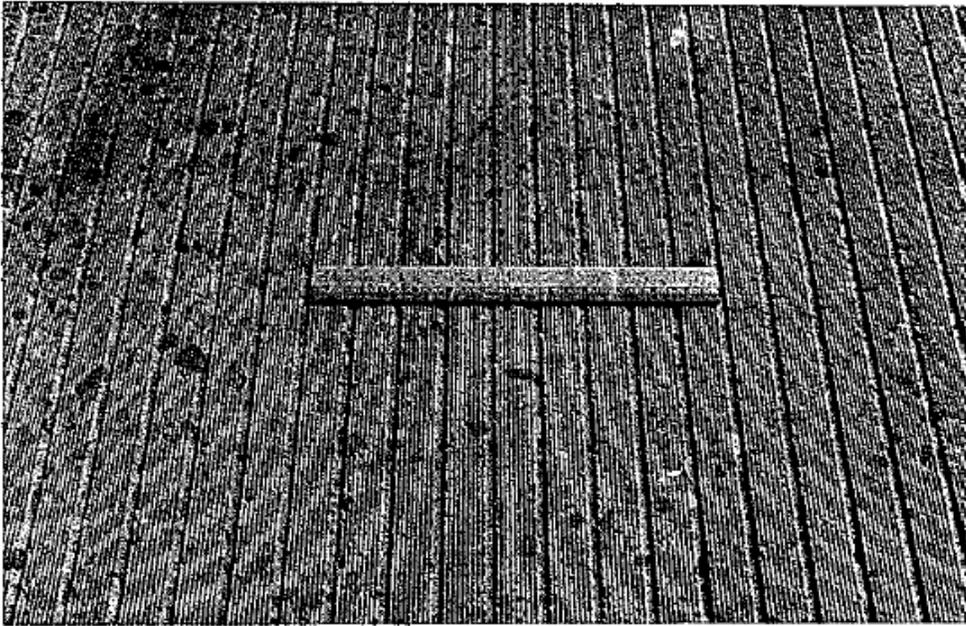
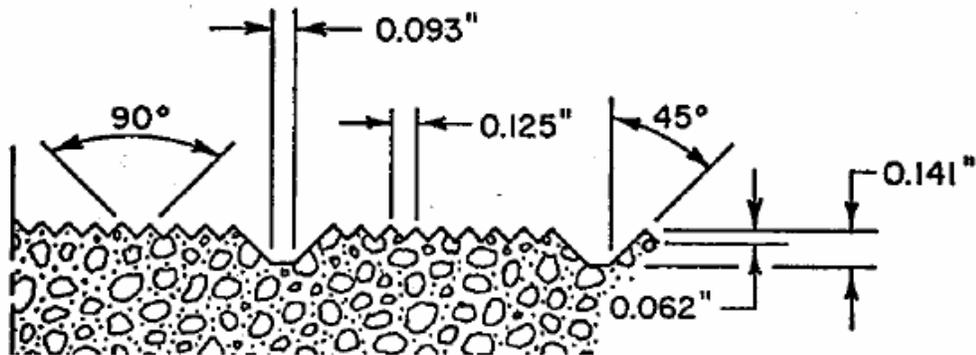
Figure 3 LWP Christensen Diamond Services Company Style 15 Grooving Pattern¹

wheelpath (Figure 3), was tested because it had been reported as being superior at increasing the coefficient of friction on smooth pavements⁵.

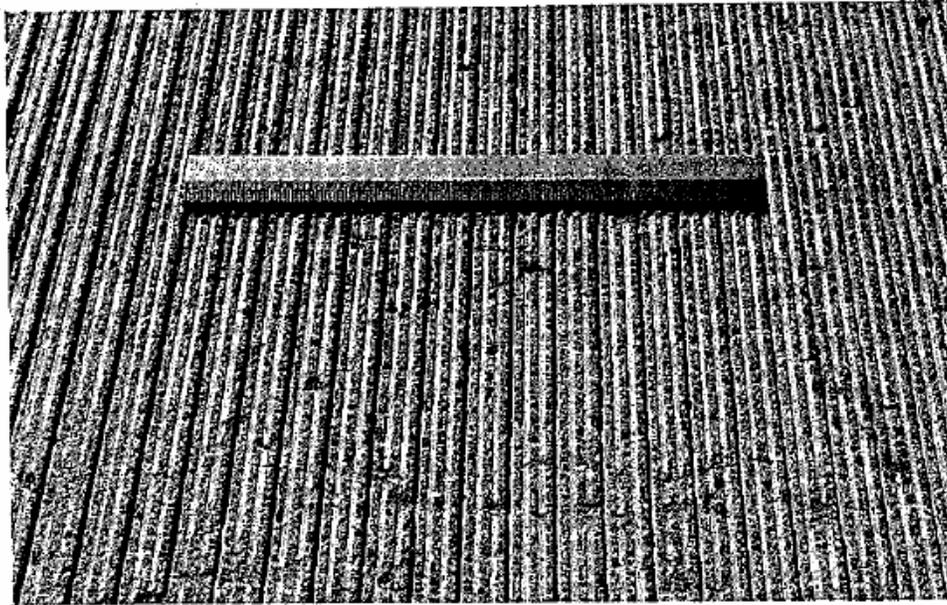
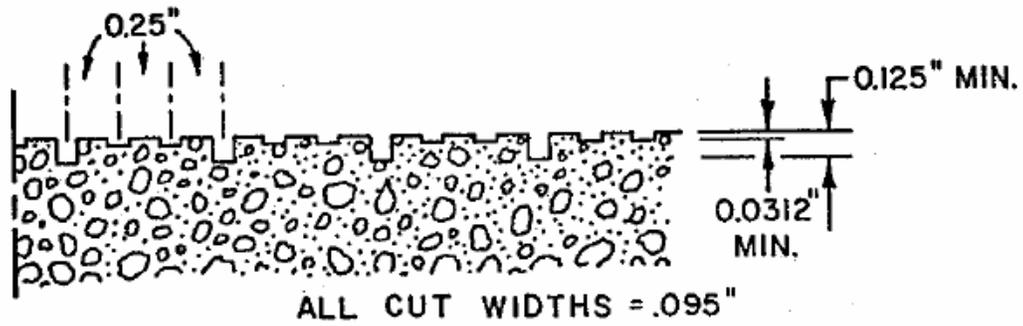
Figure 4 RWP Style A Groove Pattern¹

The Style A groove pattern, used in the outer wheelpath (Figure 4), had been used at locations where it was desirable to improve the coefficient of friction a significant amount. This pattern consisted of cuts 0.95" x 1/8" on 3/4" centers with two 0.095" grooves equally spaced between those on 3/4" centers and not more than 1/16" deep.

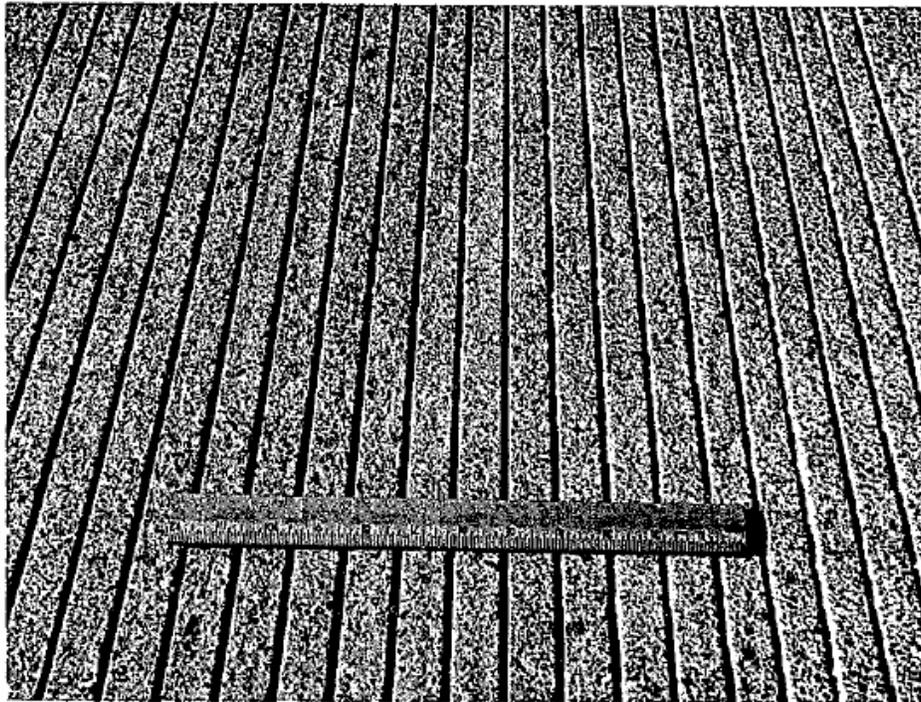
Figure 6 LWP 1/8" X 1/8" at 1" Centers Grooving Pattern¹

The left wheelpath (See Figure 6) consisted of 1/8" X 1/8" grooves spaced on 1" centers while the right wheelpath (See Figure 7) consisted of 1/8" X 1/8" grooves spaced on 1/2" centers. The 1/8" by 1/8" groove pattern appears to have been considered the standard groove width for this experiment and the effect of varying the groove spacing was determined. In the original experiment, this groove configuration was evaluated at spacings of 1/2", 3/4" and 1". The 3/4" spacing was tested at Site 05B.

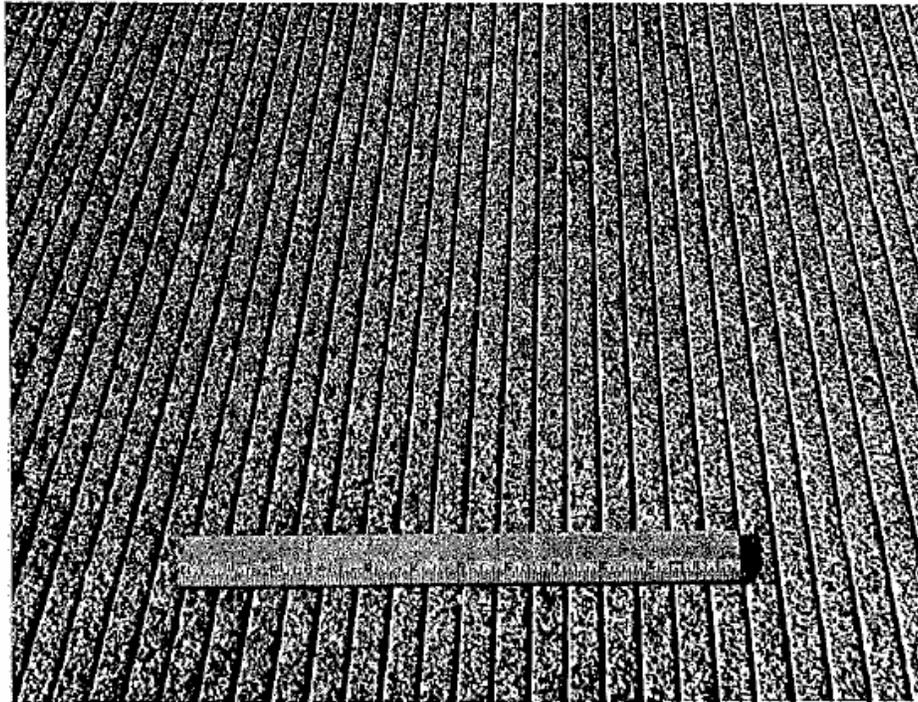
Figure 9 LWP 0.095" X 1/8" at 3/4" Centers Grooving Pattern¹

This site is located east of site 05C and is approximately in the middle of the one mile long profiler test section as indicated in Figure 1. It consisted of two different groove patterns, one in each wheelpath. The left wheel path, approximately 3 ft in width, consisted of 0.095" X 1/8" grooves spaced at 3/4" centers (see Figure 9). The right wheel path, approximately 2 ft in width, consisted of 1/8" X 1/8" grooves also spaced at 3/4" centers (See Figure 10). The center of the roadway (e.g. between the wheelpaths) was the original drag texture. At the time of the 1969 experiment, the California Public Works Department, Highways Division was evaluating the narrower 0.095" groove width against the commonly used 1/8" X 1/8" groove width. It was believed the 0.095" groove width imparted less roadway sensation to the cyclists⁶.

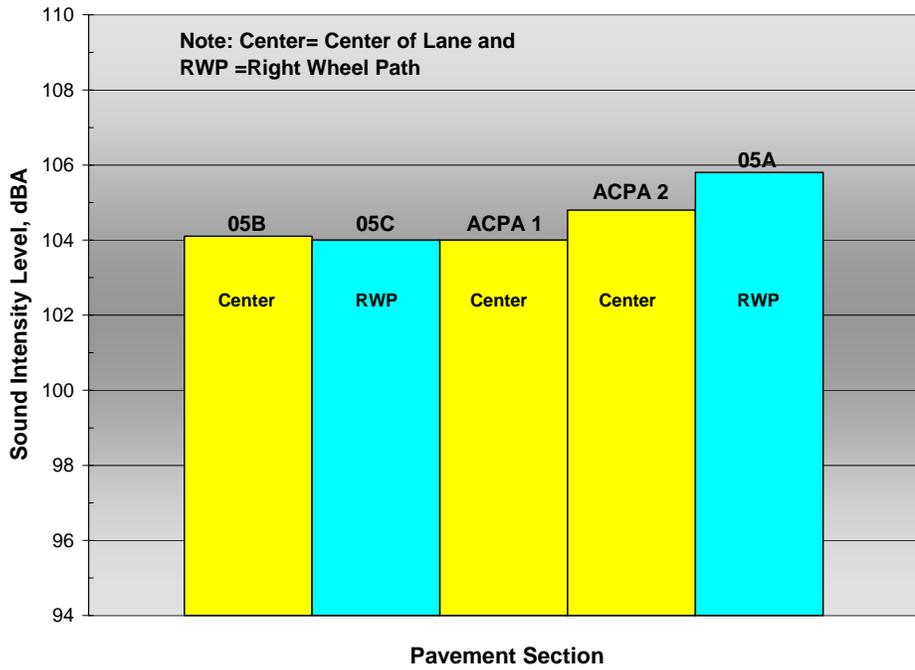
Figure 12 Comparison of Center of Lane to Right Wheelpath Drag Texture OBSI Overall Results

Figure 12 provides a comparison of the center-of-lane to the right wheelpath results for the OBSI overall A-weighted results. From this figure it does not appear that there is a significant difference between the two test locations. Note that 05A is not being considered since it is in the EB direction and has more joint slap included.

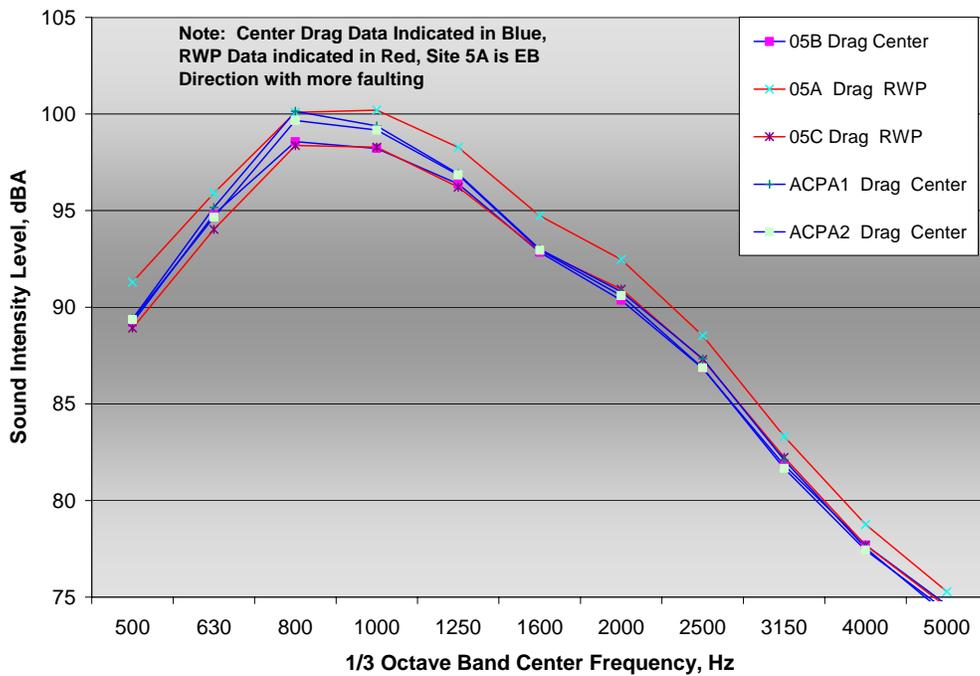
Figure 13 Spectral Plots Comparing Center-of Lane to Right Wheelpath Drag Texture OBSI Results

Figure 13 indicates the spectral plots for these same surfaces. As before, there does not seem to be a significant difference between the two wheel placement locations. The RWP data points are shown in red and tend to envelope the center-of-lane results shown in blue.

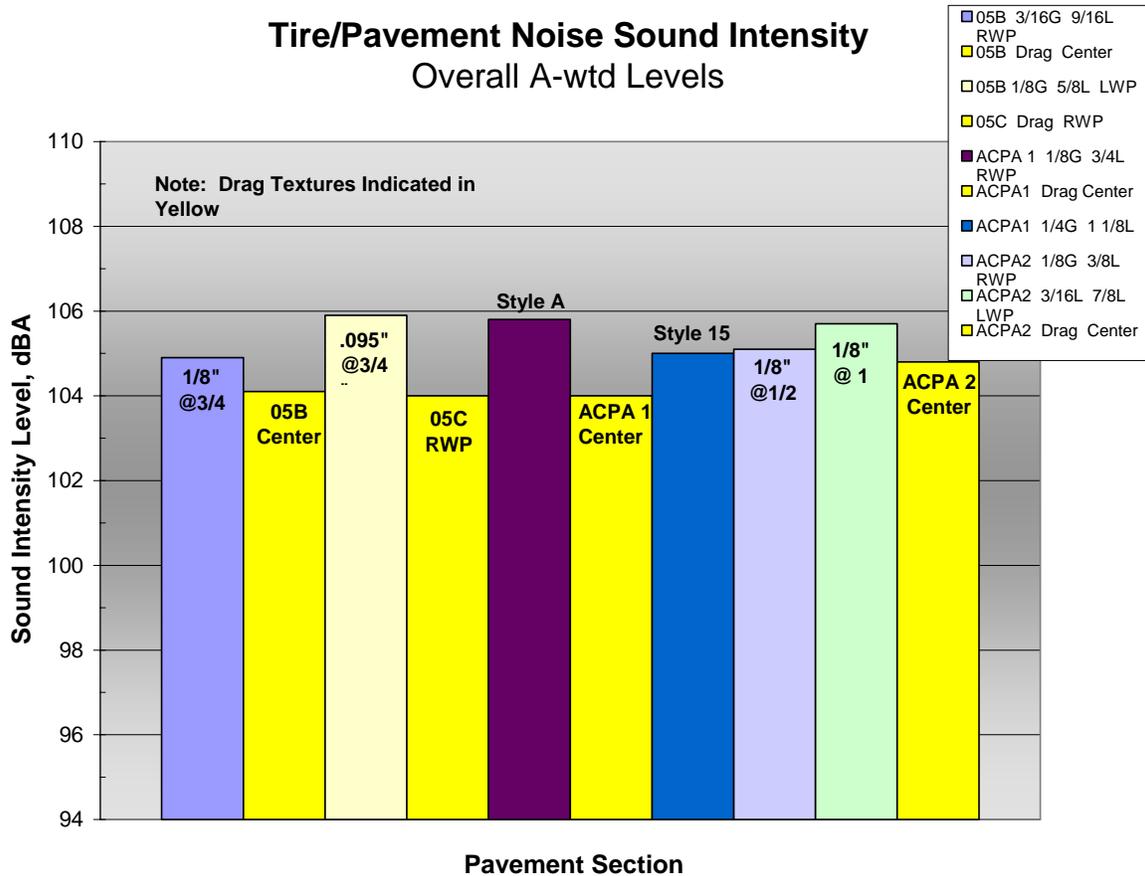
Figure 14 Overall OBSI Level of Drag and Diamond Grooved Test Sections

Figure 14 indicates the results for both the drag textures and the various groove patterns. Although all test results are within approximately 2 dBA, it appears that the drag textures are slightly quieter than the grooved sections. This would tend to suggest that grooving does not provide a long term benefit for noise reduction.

Figure 14 indicates that the two patterns are within one dBA of each other and that this is probably too close to be considered significant. It should probably be assumed that no difference exists.

The results presented in Figure 14 do not indicate that either of the friction improvement surfaces resulted in an increased noise level after 28 years.

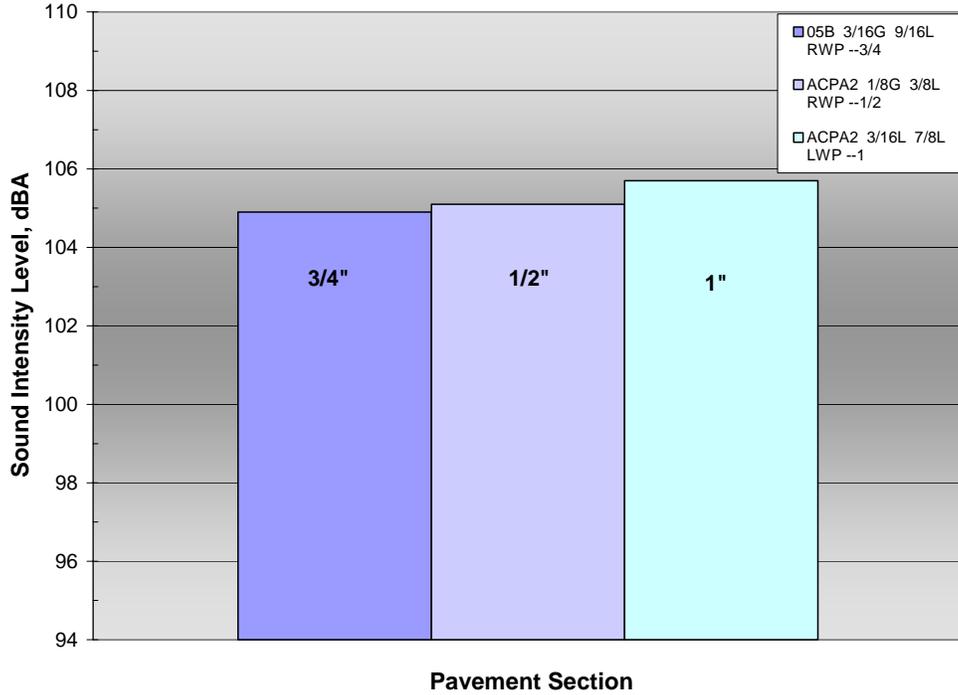
Figure 15 Indicates the Overall OBSI Levels for the 1/8" Groove Width for Different Spacings

Figure 15 indicates the overall OBSI levels for the three groove spacings (e.g. 1/2", 3/4", and 1") constructed in the 1969 experiment. As indicated in Figure 15, there does not appear to be a significant difference resulting from the spacing effect. All three results are within one dBA.

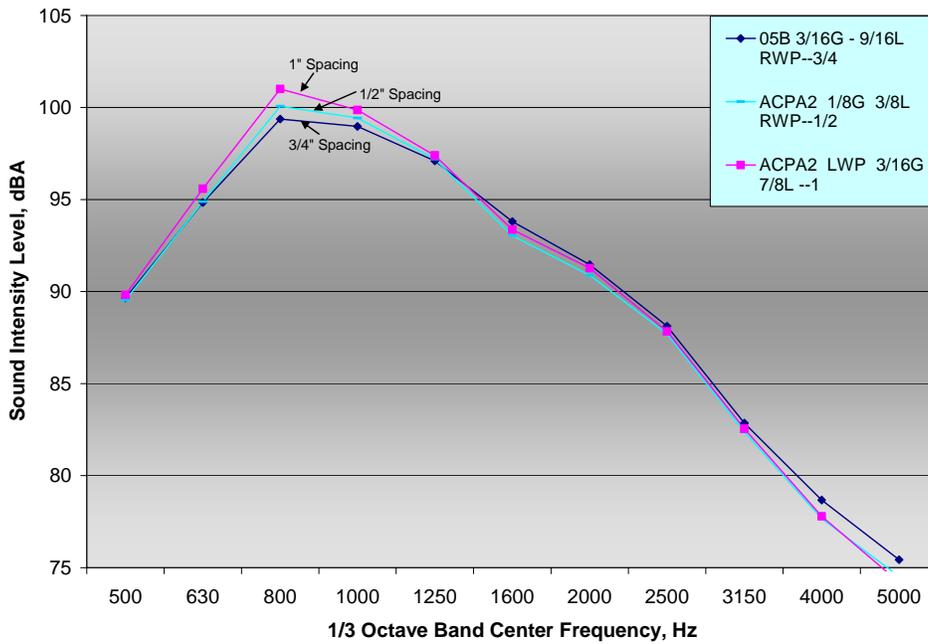
Figure 16 OBSI Spectral Plots Indicating the Effect of Spacing Width on 1/8" Groove Patterns (1/2", 3/4", 1")

Figure 16 indicates the spectral plots for these same surfaces representing the 1/8" groove width constructed at three spacings; 1/2", 3/4" and 1". As before, there does not seem to be a significant difference between the spacing. However, at the 800 -1000 Hz centerband frequencies there does appear to be a slight difference.
