Minimize Wheel-Slap: Keep Your Joints Narrow

**American Concrete
Pavement Association**

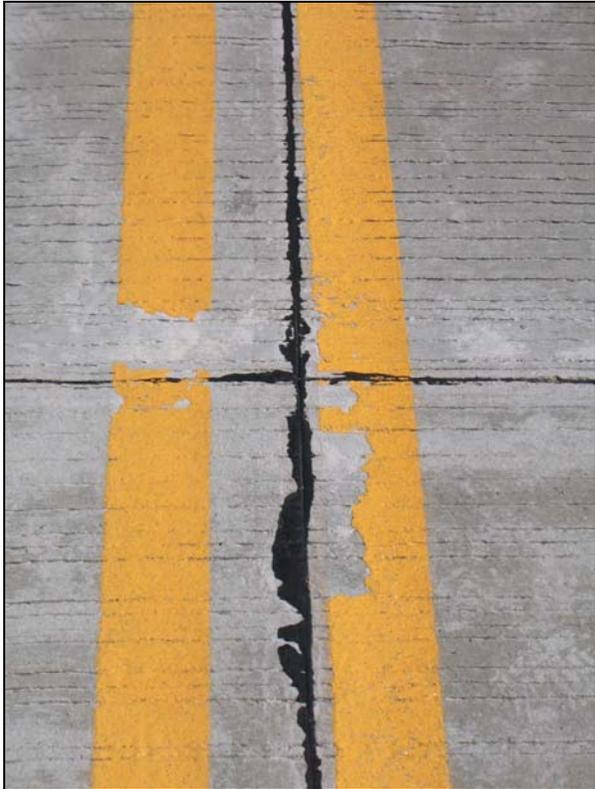
Typical overfilled joint, which can also cause an annoying sound similar to wheel slap when tires cross the joint.

- Overfilled joints at one project also caused a noise similar to wheel slap. It was exactly the same noise that you would hear on an asphalt pavement that has had crack sealing, which uses “banding” to spread the sealant around the surface of the crack.
