# CPR – REBUILT TO LAST

## Eielson Air Force Base, Fairbanks, AK

### >>> DIAMOND GRINDING AND GROOVING

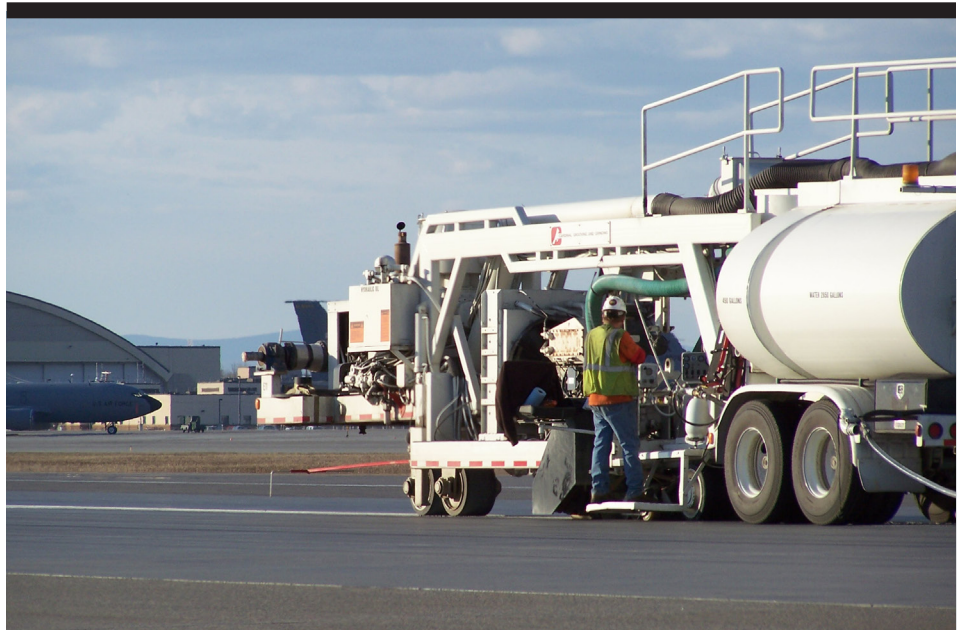
**IT IS NO SECRET** that winters in Alaska can be harsh—not just for its residents, but also for the state's infrastructure. At Eielson Air Force base (AFB) in Fairbanks, drastic variations in seasonal temperatures of around 100 degrees and extreme winter weather conditions accentuated by the wear caused by constant snow and ice removal had damaged and deteriorated the 14,530-foot concrete keel section of runway 14-32, which is used by fighter aircraft from the 354th Fighter Wing and by large refueling tankers. Repairs and retexturing were required to avoid potentially serious and expensive accidents that could be caused by aircraft losing control on the worn surface.

Approximately 200 locations were repaired on the runway where spalling of the concrete had occurred. Sizes and depths of spalled areas ranged from 5 to 12 inches in width and length and 4 to 14 inches in depth.

Concrete was originally chosen for the runway's 75-foot-wide keel section since it is a material that can withstand the major temperature variations, harsh winter conditions and the process of repeated snow removal by plows. Diamond grinding was used to remove the existing grooved surface before a new grooved surface could be created. In addition, there was a requirement to remove old sealant from the joints of the runway and replace it with new sealant material, followed by striping and marking.

The project was to be completed in four phases. Each phase was to be completed with only a seven-day buffer between the end of one phase and the commencement of the next. In each phase, the old grooves had to be ground out to the satisfaction of the engineer before new grooves could be cut into the runway. Then the old sealant was removed and the joints cleaned, so that new sealant could be installed.

The 14,530 feet of grinding and grooving work was broken down to four phases measuring 2,500, 4,750, 4,750 and 2,500 linear feet. The average depth of the grooves to be ground out was 0.25 inches.
