# Diamond Grinding for Roadway Noise Control

Areg Gharabegian and Emery Tuttle, Parsons Corporation, Pasadena, California

**The results of resurfacing a roadway to reduce the noise from tire/pavement interaction are presented. Effects of truck traffic and the use of soundwalls for environmental noise control are considered as well.**

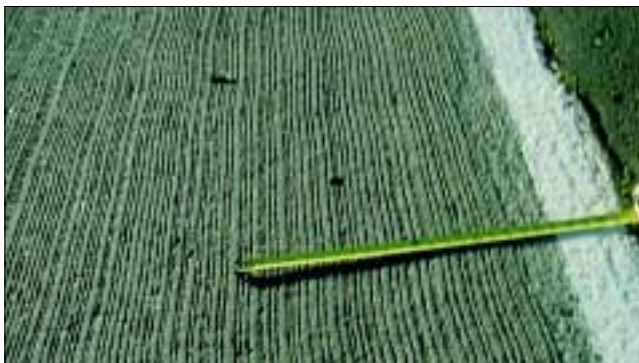
Figure 1. Longitudinal grooves of Route 101 at the test segment.

These considerations led to the selection of a measurement location along northbound U.S. Highway 101 near the City of Geyserville. In this area there is an adequately long section of longitudinally grooved pavement with a nearby section of smooth, diamond ground pavement. The measurement site for the grooved pavement surface ('before') was selected based on its similarity to the highway areas where the road surface was diamond ground ('after'). The two sites were within several miles of each other. Figures 1 and 2 show the surface of Route 101 in the area with longitudinal grooves and areas with diamond grind, respectively.

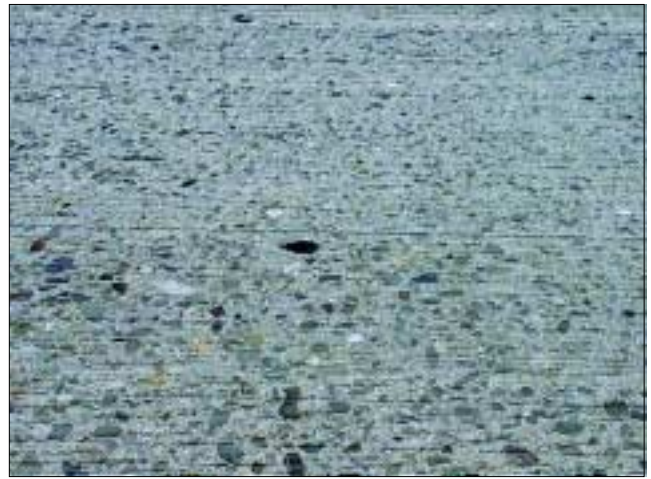
Figure 2. Route 101 surface after diamond grinding.

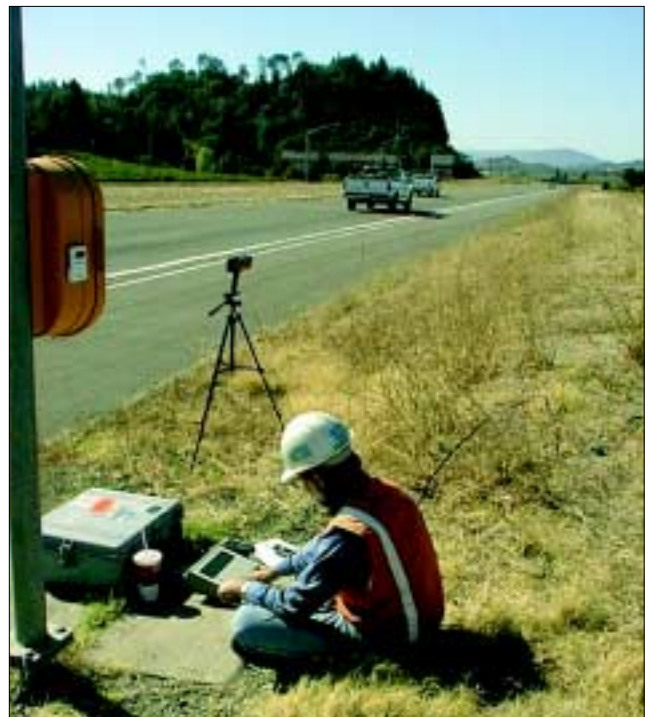
Figure 4. Measurement instruments and the operator.

**Pass-by Spectrum Noise Measurements.** The objective of the measurements was to collect data for individual vehicle passbys. Light traffic conditions at this location of U.S. 101 made this possible. A Larson Davis model 2900 2-channel real-time spectrum analyzer (RTA) was set up to measure and store 1/2-sec intervals of the sound level time history for both the overall broadband and 1/3-octave frequency bands. Channel 1 recorded the noise level at a distance of 7.5 m (25 ft) from the centerline of the outside lane of travel of northbound U.S. 101. Channel 2 recorded noise levels at 15 m (50 ft). Figure 3 shows a schematic diagram of the arrangement of the noise measurement instrumentation. Figures 4 and 5 show the measurement site for the longitudinally grooved (Site 1) and Figures 6 and 7 show the measurement site for the diamond grind (Site 2).

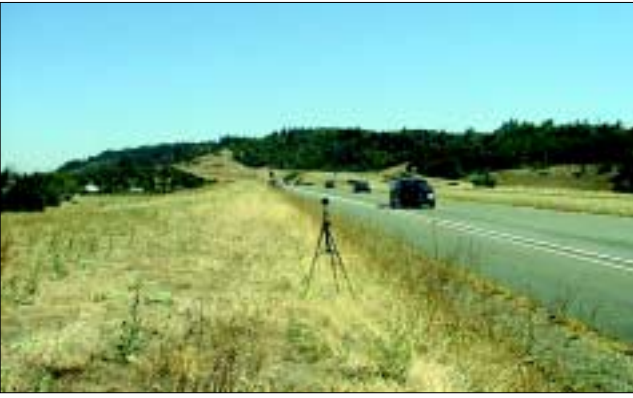
Figure 5. Microphone at 7 m (grooved Site 1).

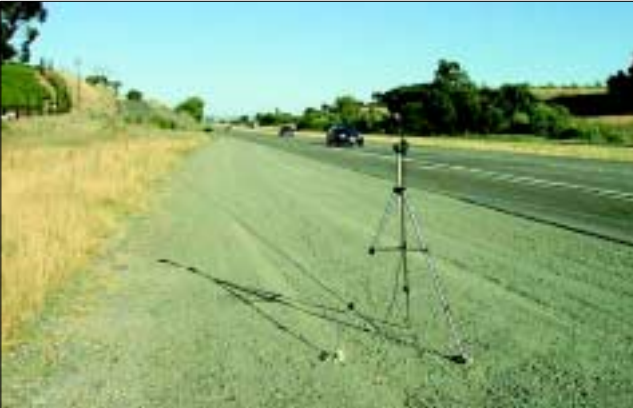
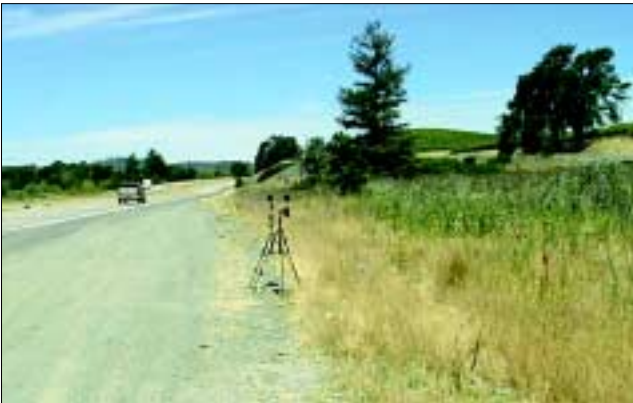
Figure 6. Microphone at 7 m, looking south (diamond grind Site 2).

Figure 7. Microphone at 7 m, looking north (diamond grind Site 2).

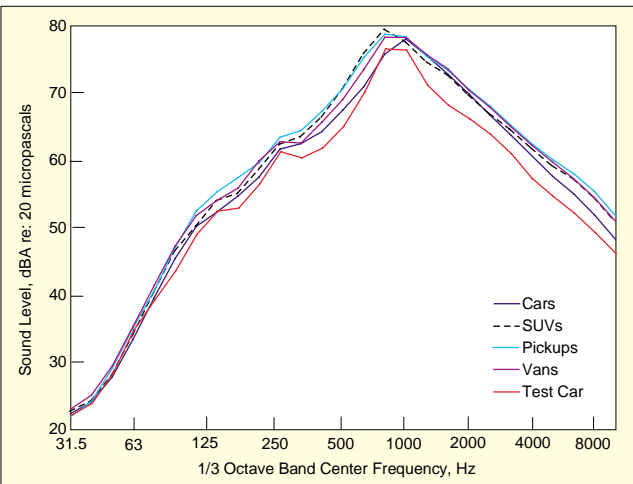
Figure 8. Average A-weighted spectrum of vehicle passbys on longitudinal grooved pavement surface at 7.5 m.

Figure 9. Average A-weighted spectrum of vehicle passbys on diamond grind pavement surface at 7.5 m.

Figures 8 and 9 show graphs of the average 1/3-octave band sound pressure levels for each vehicle type and the test vehicle for measurements at 7.5 and 15 m (25 and 50 ft) for each of the measurement sets. Results in Table 2 and different graphs show the traffic noise reduction, which resulted from tire and pavement interaction for two different types of roadway surfaces. Noise reductions shown in the graphs should be representative of noise reduction that can be achieved by diamond grinding Route 85.

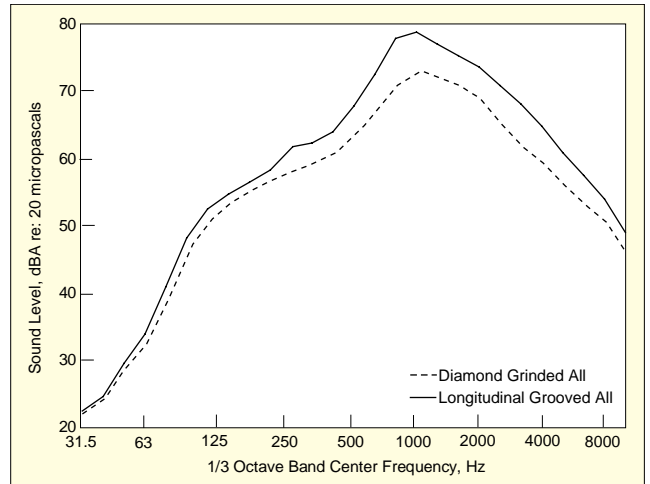
Figure 10. Comparison of the average A-weighted spectrum for the average of all vehicle types at 7.5 m.

Figure 11. Comparison of the average A-weighted spectrum for the average of all vehicle types at 15 m.

overall noise levels for 7.5 and 15 m were compared for the grooved and ground surfaces. The results show that there is approximately 6 dBA noise reduction at 7.5 m due to the diamond grinding. The results of the measurements (Sites 1 and 2) show that there is about 5 dBA noise reduction at 15 m. Figures 10 and 11 show comparisons of the average 1/3-octave band sound pressure levels for all the vehicle categories at 7.5 m (25 ft) and 15 m (50 ft) for Sites 1 and 2, respectively.

This study was conducted to determine if the noise generated by the interaction of tires and pavement surface would be lower for a PCC roadway surface that had been diamond ground as opposed to a surface that had longitudinal grooves. Results of this study indicated that the average noise drop of the maximum measured single pass-by overall noise levels is approximately 6 dB at 7.5 m (25 ft) and 4 dB at 15 m (50 ft). Therefore, the single vehicle 'pass-by' measurements indicate noise from tire/pavement interaction is likely to be perceptibly quieter for a diamond ground pavement vs. a pavement with longitudinal grooves. This is especially applicable to a roadway where there is a heavy truck ban or little truck traffic. At a roadway where there are large numbers of heavy trucks a noticeable noise reduction may not be achieved because the main truck noise comes from the engine and exhaust stack. Measurement results show that the noise drop starts at 160 to 200 Hz, but the main drop is between 500 and 2000 to 4000 Hz.
