wheel rut repair presents affordable solution to extend concrete life

Rut Repair Techniques are Timely and Effective for I-80 in California's Sierra Nevada Mountains

Caltrans Issues Emergency Contracts to Repair Pavement After Heavy Tire Chain Use and Record Snowfall

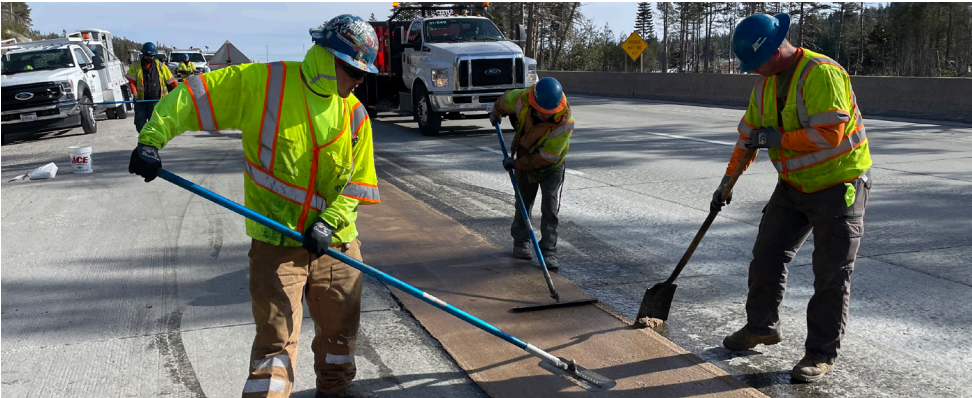
Q&D Construction was awarded one of the five contracts. Under the \$15 million contract, the company performed 34 miles of wheel rut repair from the I-80/State Highway 267 interchange in Truckee, California to the state border with Nevada. To conduct the work, a 3.5-foot-wide diamond grinding head cut the wheel rut with an edge depth approximately $\frac{3}{4}$ inch. The ruts were shot blasted, providing proper surface preparation to adhere to the backfill material. Then, a high strength backfill material was placed in the wheel rut. The material was field batched by volumetric trucks and dispersed from the trucks into the ruts. A modified skidsteer with a screed attachment was then utilized to strike and smooth the surface. Q&D Construction performed a light profile grind as a final step to ensure smoothness, followed by joint resealing.
