Dowel Bar Retrofits: *The History of Repairing Faulted Pavements*

America's highway network was created in the 1950s, kicking off decades of long-lasting service by concrete pavements. However, one unforeseen structural issue arose that needed to be addressed: due to a lack of effective load transfer between concrete slabs, faulting occurred. A cost-effective solution in the form of dowel bar retrofit—a pavement preservation technique still in use today—was developed.

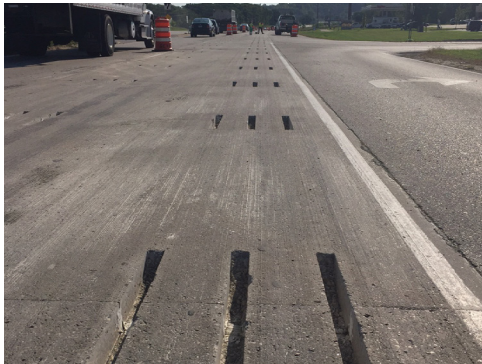
1

Cut slots.
(Typically, two to four slots are cut across a joint or crack, parallel to the centerline in the primary wheel paths.)

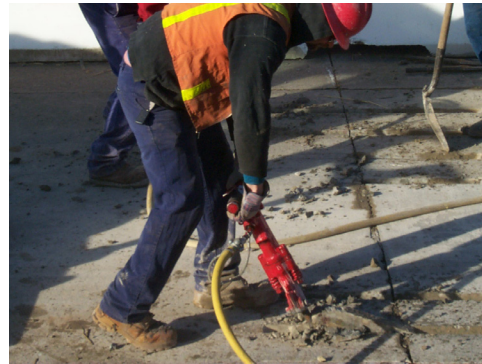
2

Remove existing concrete from slots and clean slots of all debris.

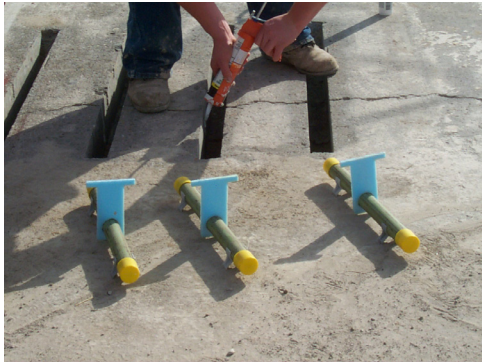
3

Place caulking compound at all joints/cracks.

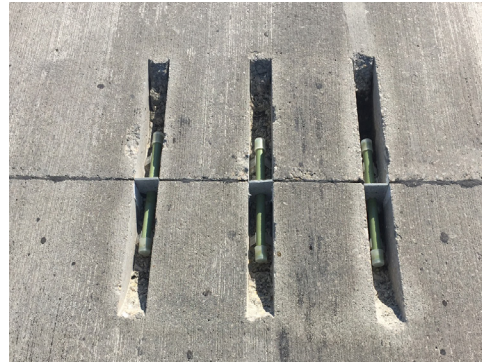
4

Place the dowel bar assemblies in slots. Assemblies include the bars (typically steel), end caps, coreboard and chair.

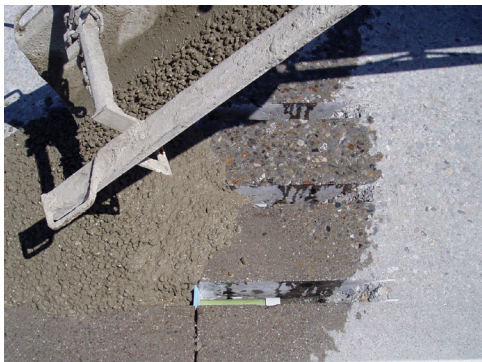
5

Finish and properly cure the patching material.

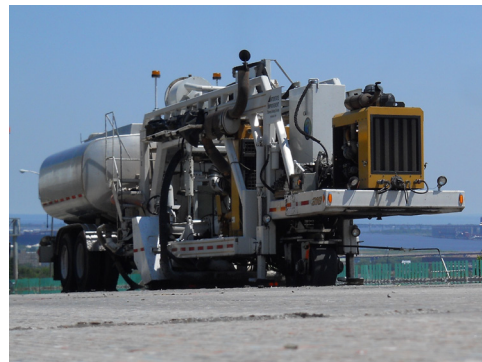
6

Diamond grind the pavement surface to remove excess patch material and remove existing faults.

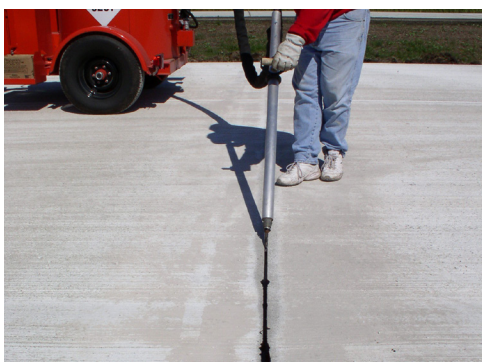
7

Seal cracks and reseal transverse joints.

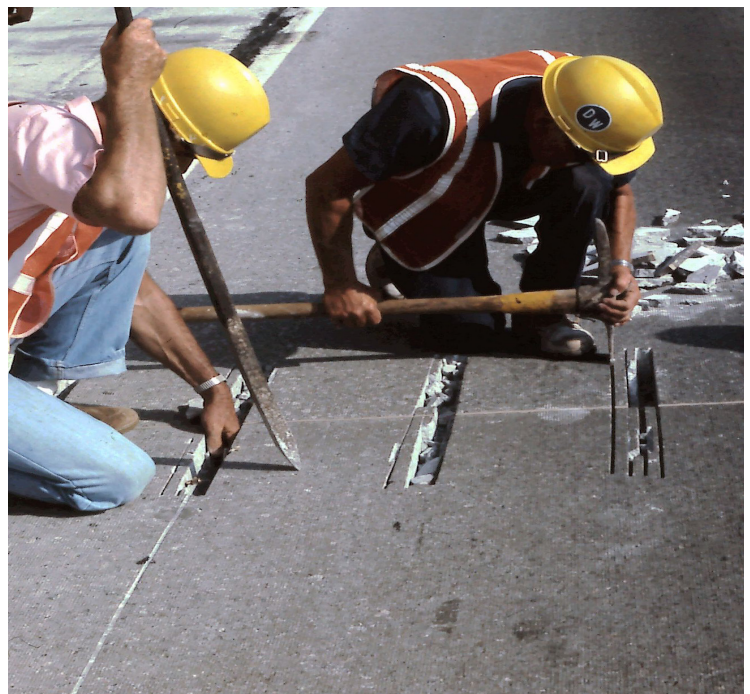
Devices placed were the Georgia Split Pipe, the Figure Eight Device used in experiments in France, the Vee Device published in the 1977 FHWA report, the Double Vee Device developed at the University of Illinois (and sold under the trade name of LTD plus), and dowel bars. To test the dowel bars, the slots for the dowels originally were to be cut with a specially built roto mill mandrel, but a field trial showed that there was too much damage to the joints and the slots were cut instead with closely spaced single saw cuts and the fins were removed with crowbars. Core holes were drilled for the placement of the other devices.

Patching materials used on the project included three types of fast-setting grouts, polymer concrete and plain fast-setting concrete. The number and spacing of the various devices and dowel bars also were variables in the project.

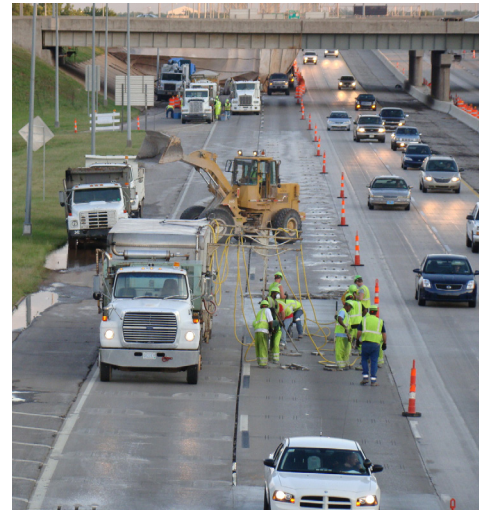
A physical survey conducted before work began revealed severe panel damage and faulted pavement on I-44. The road was in desperate need of repair; the transverse joint faulting was in the 1/4-inch to 3/8-inch range with isolated 1/2-inch to 5/8-inch faults and variable 1/4-inch to 3/4-inch faulting at the longitudinal joints.
