Field Evaluation of the Effect of Joint Sealant on Transverse Joint Slap Noise

Draft August 6, 2008

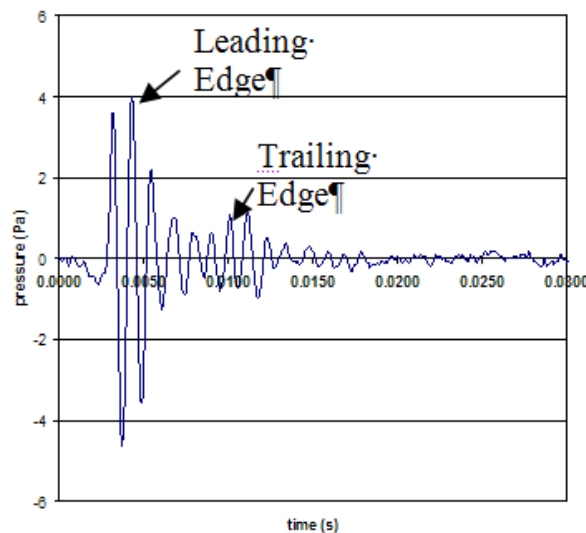
As a tire passes over a transverse joint in a pavement, a transient noise is generated as indicated in Figure 3. The noise generation is due to the vibration in the tire tread and carcass created by the impact with the joint. The first and largest response is the leading edge impact as indicated. The vibrations attain their maximum impulse shortly after leading edge contact and then begin “ringing out” until the trailing edge of the tire contact patch impacts the joint again, when a second impulse occurs with attendant “ringing out” as indicated. The total event happens over a period of approximately 0.02 seconds at 30 mph.

Figure 3 Sound Pressure (e.g. noise) Resulting from Contact of Tire with Transverse Joint @30 MPH

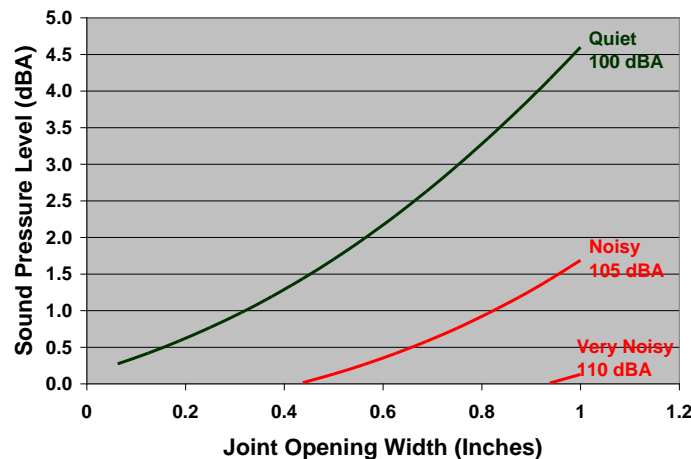
However, this “cellar” value is also a function of the existing pavement texture. As indicated in Figure 4, the noisier the existing texture the wider the joint opening width before overall noise level is affected. Had the existing texture been noisier, the “cellar” value (e.g. the joint opening width at which joint slap contributes to overall level) would have been wider. Figure 4 indicates the joint opening effect in relationship to the existing texture noise level for three pavement conditions; quiet (100 dBA), noisy (105 dBA), and very noisy (110 dBA).

Figure 4 Transverse Joint Opening Width Effect in Relationship to Existing Pavement Texture Noise Levels @ 60 MPH

For a common joint opening width of 3/8 inch, the impact on overall noise level would be insignificant for both the noisy and very noisy textures. It would add approximately 1 dBA to the overall level for the quiet texture. As indicated, as the existing pavement texture noise level (e.g. background noise) increases, the contribution of the joint opening effect becomes less and less. For the quiet pavement surface shown in Figure 4, the joint opening effect begins around 1/8 inch opening size and adds about 4-5 dBA to the overall tire-pavement noise level at a one inch opening width. For the very noisy pavement, the joint opening size needs to be approximately one inch to contribute to the overall noise level at the tire-pavement interface, and even then it is negligible. This suggests that the joint opening width needs to be considered in the design process when quiet pavements are a concern.

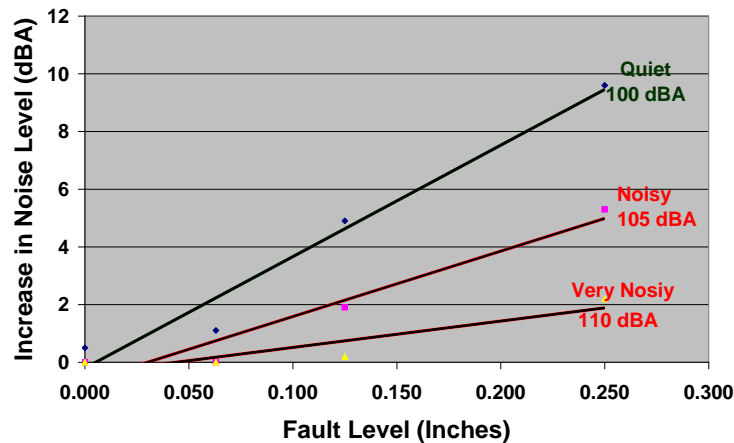
Figure 5 indicates the affect of different fault levels on joint slap (e.g. step-off case) for the three surface noise levels previously described. A joint opening width of 3/8 inch was used for all testing and a sealed condition with a 3/8” recess. As indicated in Figure 5, a 1/4 inch fault level can add approximately nine dBA to a quiet pavement surface while only adding approximately two dBA to the very noisy surface.

Figure 5 Effect of Fault Level on Overall Tire-Pavement Noise Level as a Function of Surface Noise Level @ 60 MPH

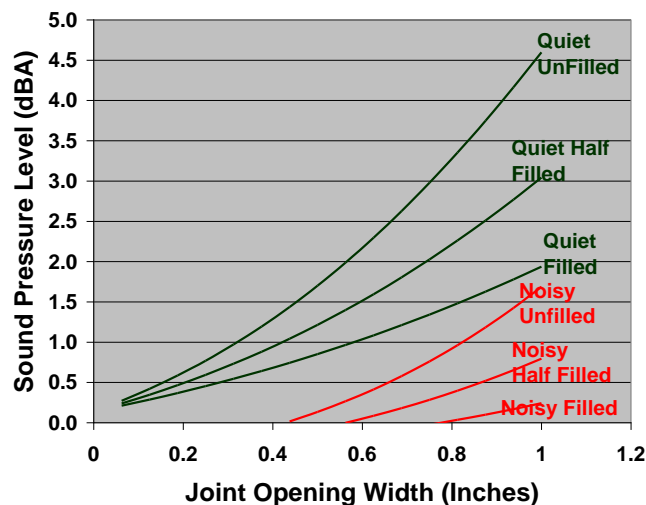
One of the effects discovered by Purdue was the pronounced influence that sealant recess or existence has on overall tire-pavement noise level. This effect is indicated in Figure 6. For this example, the filled condition represents a 1/8 inch recess, the half filled condition, a 1/2 inch recess condition, and the unfilled a 1 inch recess condition (e.g. no sealant used). In Figure 6, both the sealant recess depth and the joint opening are varied so that the combined effect of these features can be observed. Due to sealant sag, the 1 inch joint filled condition has approximately a 1/4 inch recess instead of the targeted 1/8 inch. Only silicone sealant, with a backer rod, was used in this comparison.

As indicated, the sealed condition provides a quieter pavement than the unsealed or the half sealed conditions. The filled condition (e.g. sealed) reduced the overall noise level approximately 2.5 dBA for the quiet pavement and 1.5 dBA for the noisy pavement for the one inch joint opening. For the very noisy pavement the effect was on the order of 0.1 dBA and should be considered negligible. For a typical transverse joint width of 3/8", the sealant effect results in slightly over 1/2 dBA difference. For a narrow joint of 1/4 inch or less, this effect is negligible.

Figure 6 Effect of Joint Sealant Recess on Overall Tire-Pavement Noise @ 60 MPH

The Purdue TPTA testing was conducted at speeds ranging from 0 to 30 mph using both a Goodyear Aqua Tread and Michelin Tiger Paw tire. Linear regressions were developed from this data to extrapolate to the 60 mph condition. The results from the Aqua Tread and Tiger Paw tires were averaged. As an example, 142 data points were used to develop the regressions to extrapolate to 60 mph in Figure 6.

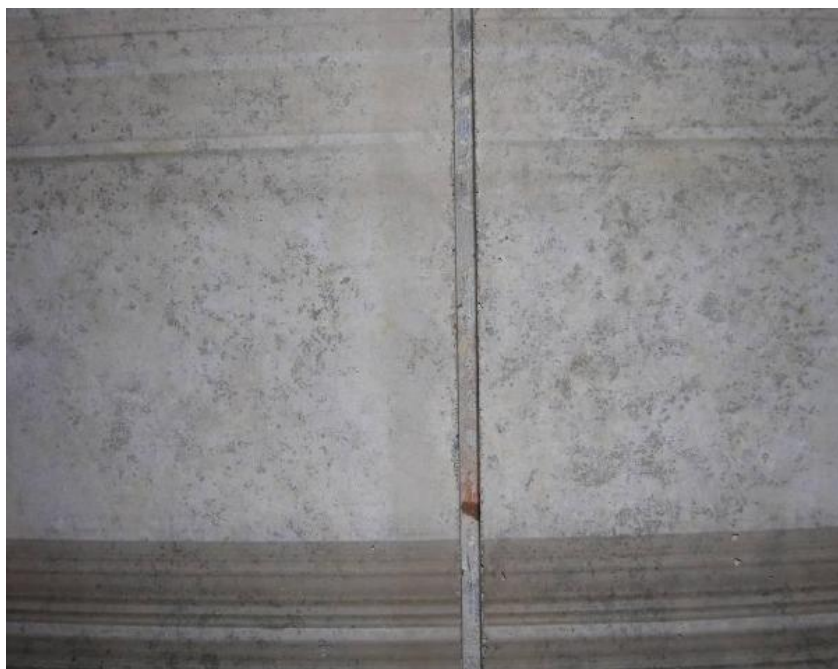
Figure 9 Photo of Purdue TPTA Surface and Joint Sealant

Prior to discussing each of the three validation attempts, it should be noted that the field conditions differ to a large extent from the TPTA conditions. For example, the TPTA testing was conducted upon a smooth cast texture in order to provide a low noise surface for the comparison. Figure 9 is a photo of that surface and one of the installed joints. As evident, the existing laboratory surface is very smooth. In contrast, the NGCS surface, indicated in Figure 10, is not a single edge but instead a serrated edge consisting of step ups and downs across the length of the joint. This provides additional/different escape passages for air trapped by the passing tire.

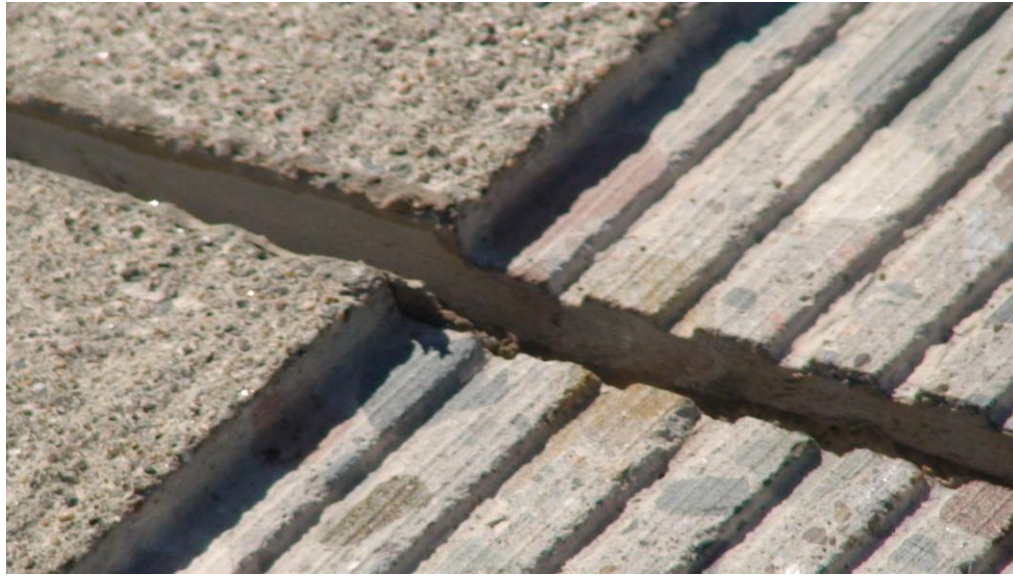
Figure 10 Photo of Existing (Left side) and NGCS (Right Side) Textures

Upon examination of Figure 10, it is also evident that the recess differs between the random transverse tined (e.g. RTT) surface (left side) and the NGCS (right side). This is the result of approximately two tenths of an inch of removal during the grinding process. Once the sealant is removed the RTT wheeltrack would have a larger unsealed depth by this same amount. In addition, the field unsealed joint could be affected by the initial contraction joint that extends beyond the bottom of the reservoir. The effect of these differences cannot be accounted for in the current evaluation.

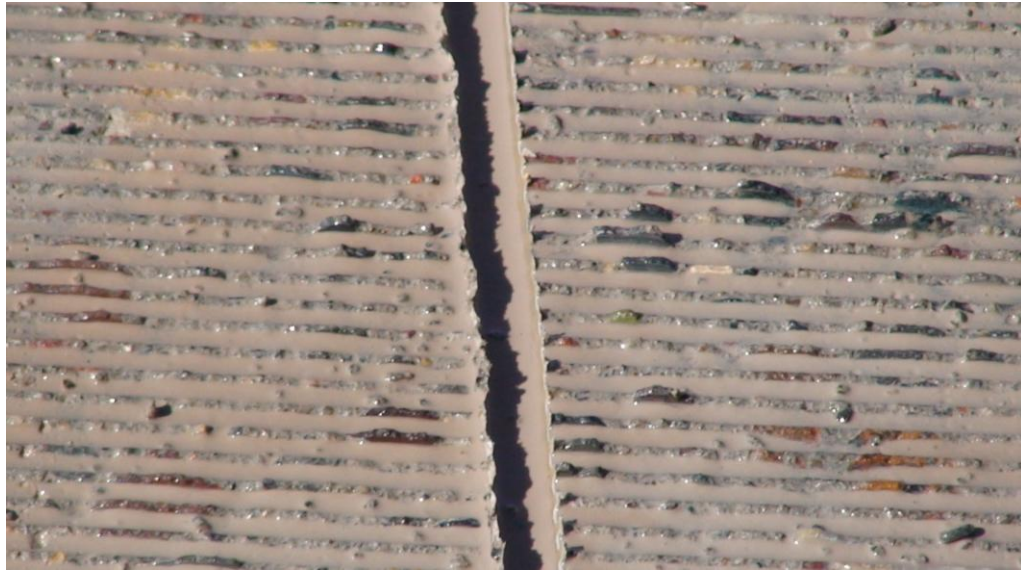
Figure 12 indicates another difference between the field and laboratory sealed condition. For the NGCS texture, the removal of the concrete reduced the recess depth and, in some instances, exposed the sealant. Whether this had any influence is not known.

Figure 12 Silicone Sealant Extending Above Surface after Grinding

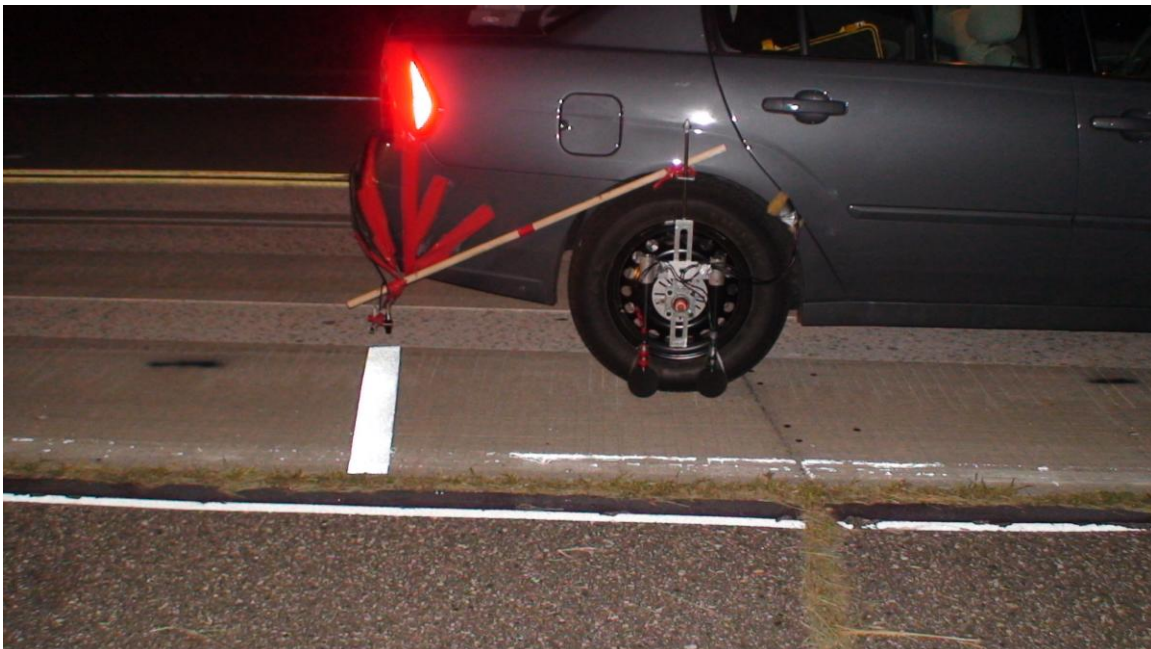
Figure 13 Side View of OBSI Equipment and Laser Trigger Suspended from Vehicle

A second attempt at field validation was attempted on 8/15/07 by a collaborative effort between ACPA and Purdue. For this attempt it was decided to use a laser to trigger the exact location of each joint in relationship to the OBSI recording. This would then be similar to what was done at Purdue on the TPTA. The plan was to measure 10 joints, ten times each providing one hundred measurements to evaluate the joint effect. A laser was mounted to the OBSI test vehicle and linked to the audio recordings through the use of the fifth channel in the B&K frame as indicated in Figure 13. (Appendix 2 has a photo of the laser dot on the roadway).

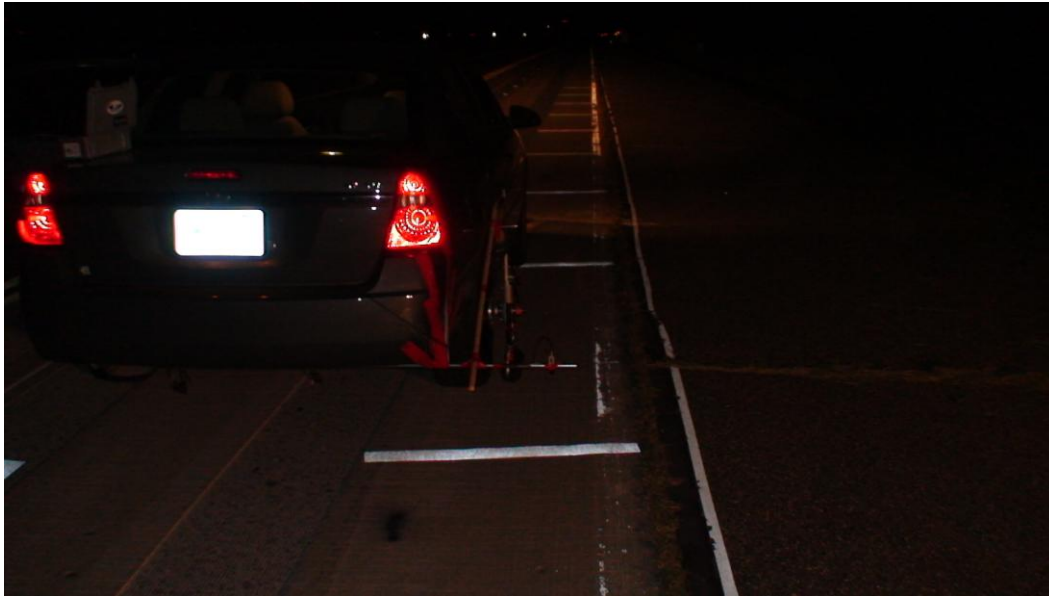
Figure 14 View of Tape and Laser Trigger on OBSI Vehicle

Reflective tape was placed in advance of each of the ten joints so that it would trigger the laser at an offset to the exact instant the tire was passing over the joint as indicated in Figures 13 & 14. In this manner, the joint location could be included in the audio recording as indicated in Figure 15. The blue lines represent the audio recording and the red line the joint location indicated by the laser trigger. The black lines indicate the window of the joint noise impulse.

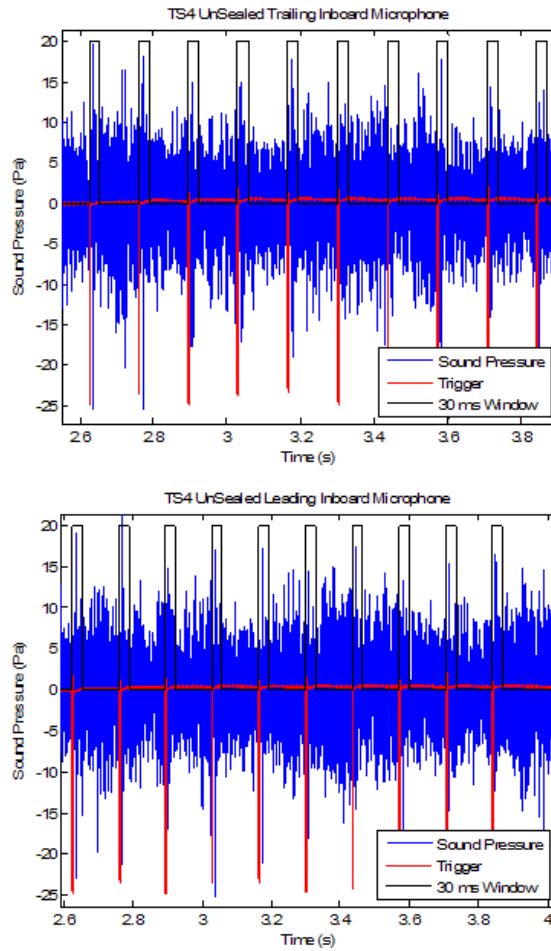
Figure 15 Joint Location Event Superimposed onto the Audio Recordings

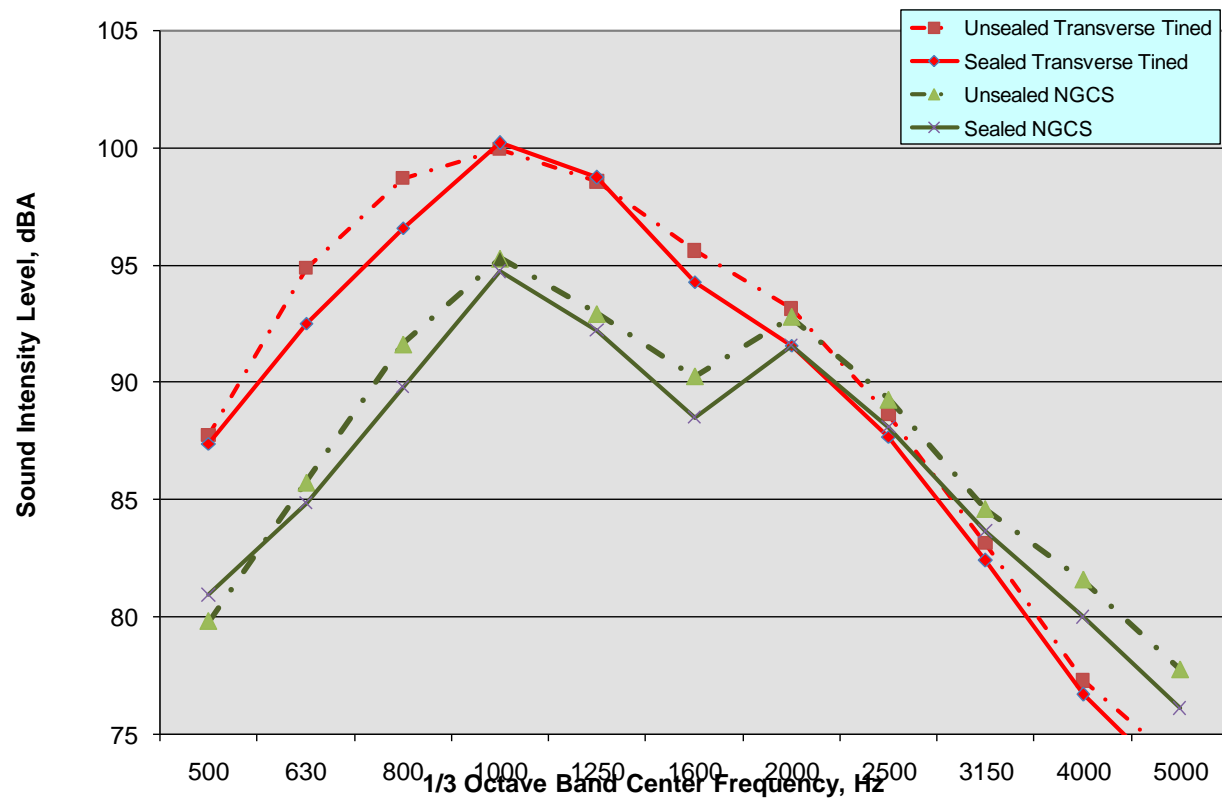
Figure 18 indicates the frequency spectrums for the two tracks and two conditions tested. As indicated in Figure 18, there is no distinct shift in the unsealed spectrum that occurs in relationship to the speed-spacing relationship of the joint slap event. Instead an overall level is noted for the unsealed condition for most all frequencies.

Figure 18 Third-Octave Spectral Plot For the Sealed and Unsealed Conditions for the NGCS and the Transverse Tined Wheel Tracks

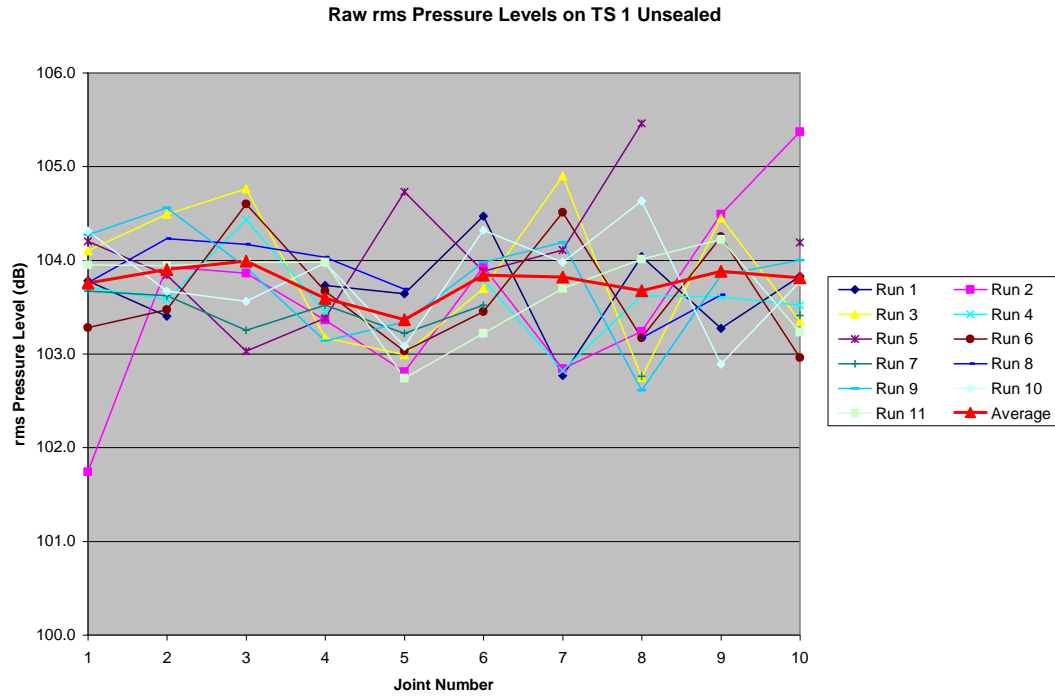
The noise for a given joint in each pass on varied by 2 to 3 dB on TS1 and 3 to 5 dB on TS4. For a given pass, the noise for each joint varied by similar amounts. The average noise for each joint was calculated. On TS1, the average SPL for each joint varies by about 0.7 dB and there are no joints that are consistently louder. On TS4, the average SPL varies by up to 2.5 dB and there are obvious louder and quieter joints.

Figure 1: Joint noise levels on unsealed TS1. The average SPL varies by a small amount and no joints are consistently louder or quieter.

Since the average joint noise levels on TS1 were similar, it was concluded that the joints were close to the intended 3/8" width and had not been altered significantly from the grinding process. On TS4, however, there are louder and quieter joints, indicating that some of the joints were altered due to the grinding process. It was concluded that the nominal 3/8" joint width was not reliable for TS4.

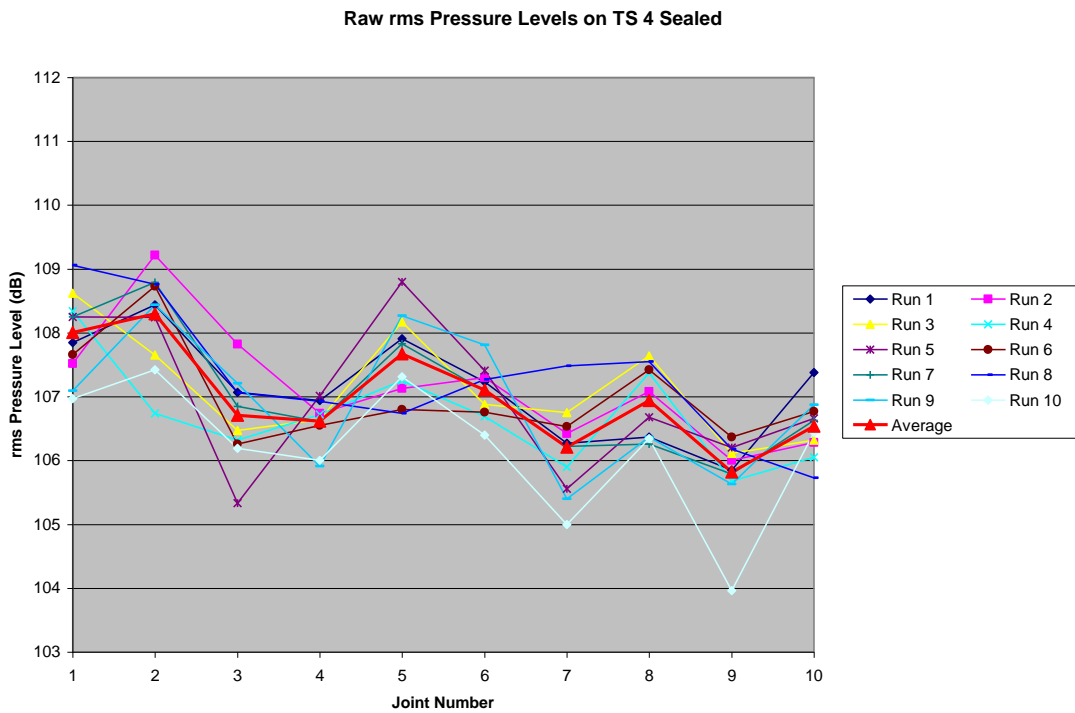
Figure 2: Joint noise levels on sealed TS4. The average SPL varies by a larger amount and some joints are consistently louder than others.
