Region Bridge Support Unit Bridge Field Services

Alleviating the Effects of Pavement Growth on Structures

January 2012

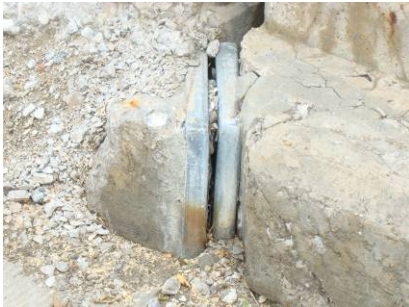
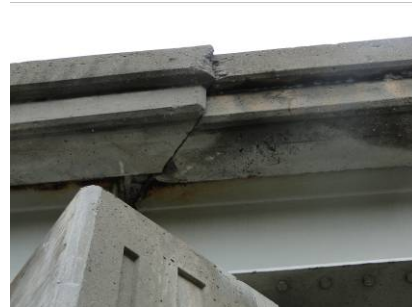
Expansion joints are often the first vital component to be affected by PG. They allow the bridge to freely expand and contract during temperature cycles, and if there is no space available for expansion damage will occur to the deck and beams beneath.

Figures 11 & 12. Expansion joints permanently closed

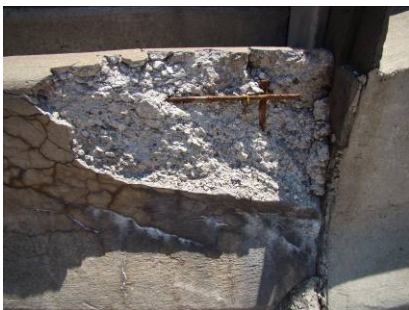
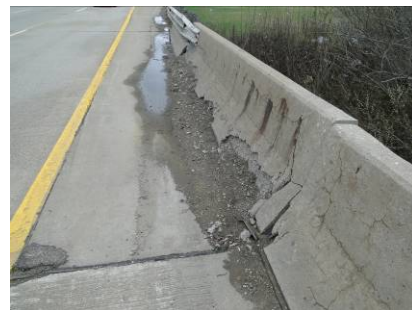
Damaged railing is often readily noticeable and may be the first element damaged. If the space separating two sections of railing at an expansion joint is less than the joint throat the railing will be tight or crushed first. The damage may also occur along the approach if the expansion joints are not on the bridge.

Figures 13 & 14. Crushed concrete railings

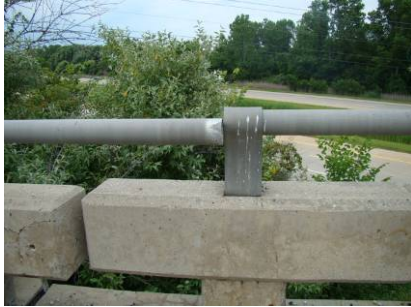
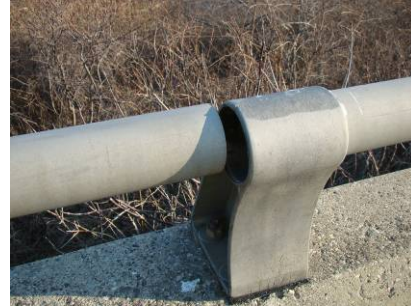
Many older structures have single and double tube railing, and tube separation is a visual sign pressure from the roadway is being applied. Look for separated sections near each end of the deck where tube railing attached to a wing wall meets railing joined to the tailspan.

Figures 15 & 16. Aluminum tube rail separation

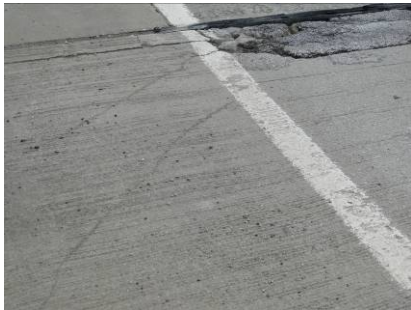
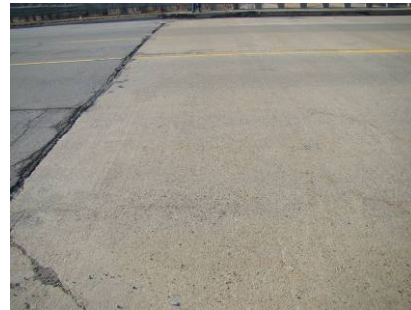
A series of cracks that propagate near the approach end of a tailspan are a feature of pavement pressure. The cracks are measurable in some cases, but are most often hairline. If more than two cracks at a forty-five degree angle to the reference line can be seen, look for other symptoms beneath the deck.

Figures 17 & 18. Diagonal deck cracks in tailspans

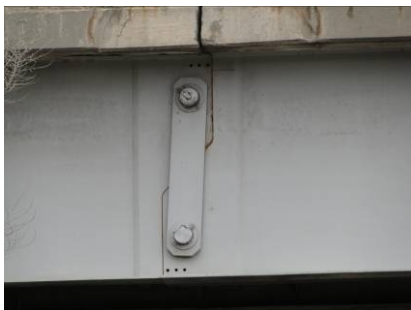
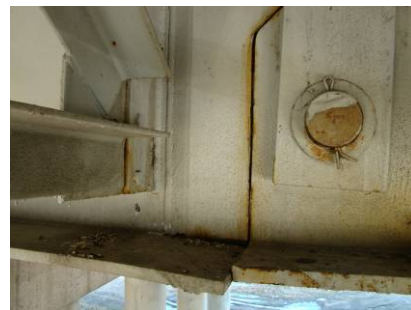
Pin and hangers are easy to see while driving, and closed ones during winter months should be investigated. Although corrosion is often blamed, a closer examination should be conducted.

Figures 19 & 20. Pin & Hangers closed during cold weather

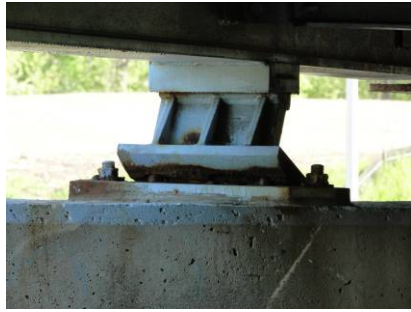
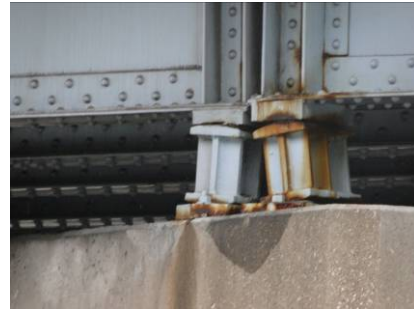
Severely tilted rockers may be an indication of PG. Taking action by only realigning the tilted rocker bearings to accommodate for thermal expansion is not a remedy. Installing a PRJ prior to beam end contact will eliminate damage to beam ends.

Figures 21 & 22. Tilted rocker bearings during cold weather

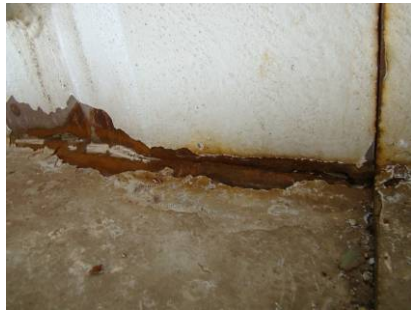
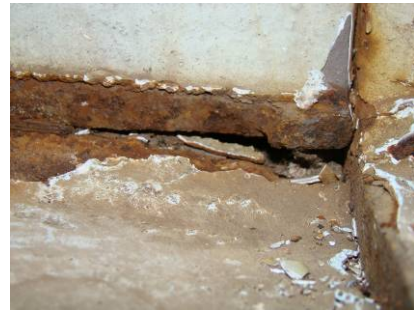
Beam end contact occurs when the effects of PG have gone untreated and the resulting damage will lead to stress cracks near the bottom flange and web interface. A hands-on inspection should be performed to determine if a crack is present that will require a bolted repair.

Figures 23 & 24. Examples of damage from beam end contact

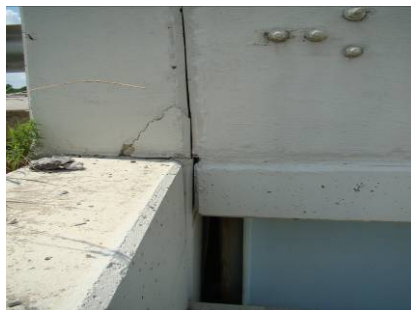
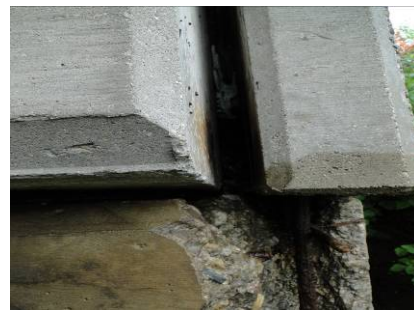
An independent backwall that is not vertically plumb may have been constructed correctly, but has since been pushed by PG. This action results in a void forming behind it causing the approach to crack. In many cases both vertical construction joints between the backwall and wing walls will open and a significant amount of subbase material may be lost.

Figures 25 & 26. Tilted independent backwalls

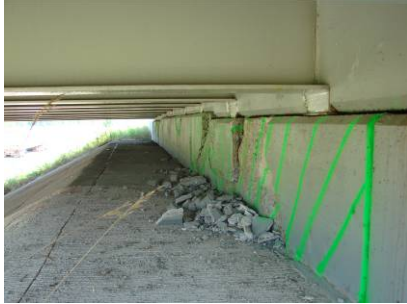
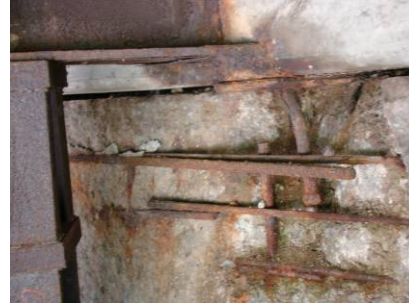
When sounding of the abutment stub reveals delaminations beneath the beams PG is present and corrective action through the installation of a PRJ must be performed. Significant spalling or exposed positioning dowels are signs of reduced bearing and will require substructure repair and temporary supports.

Figures 27 & 28. Dependent backwall delamination and spalling

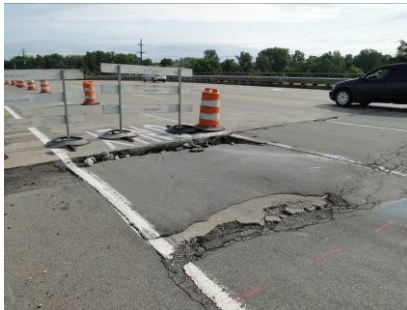
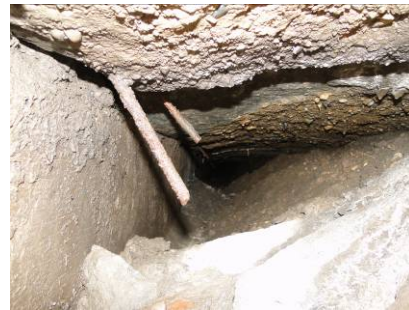
A bridge approach that has settled or been raised by PG creates additional impact force on the deck. A void beneath the pavement presents an unneeded hazard and further inspection is required to determine if it is a result of PG or poor construction.

Figures 29 & 30. Approach settlement and void behind backwall

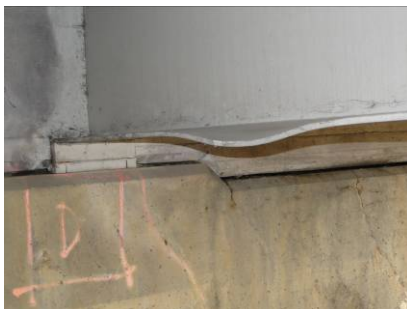
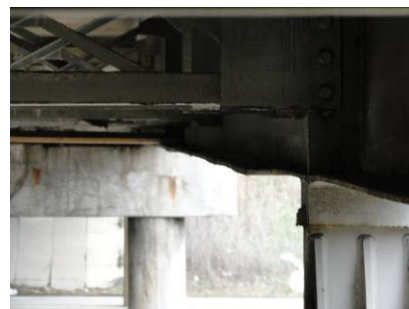
If the previous signs are ignored tailspan beams may buckle from longitudinal pavement stress. A buckled beam could possibly be heatstraightened. Retrofitting a heatstraightened beam with a bolted repair is a temporary fix, and would require attentive monitoring until replacement.

Figure 31. Buckling tailspan beam

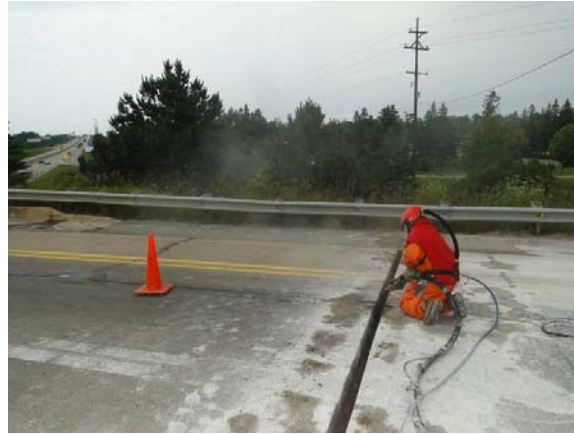
Once removed, the vertical surfaces must be dried with air and sandblasted to aid the bonding ability of the lubricant adhesive. A vacuum truck is helpful to remove slurry located in the bottom of the joint that is generated during saw cutting.

Figure 33. Sandblasting the exposed edges of pavement

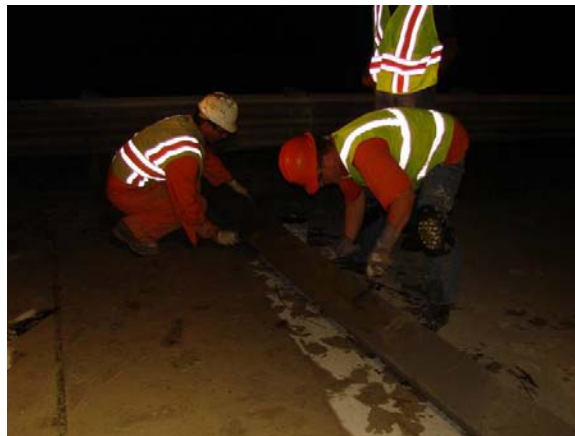
Each contacting edge of closed cell relief joint material must be coated with lubricant adhesive. Inexpensive disposable rollers or steel trowels may be used to spread the material conservatively. Once the sides are coated, the material should be pressed in place by hand working from one end to the other without stretching it. Press the foam into the void so it is recessed approximately one half inch. Tools may be cleaned with xylol or acetone to remove any lubricant adhesive residue.

Figure 34. Applying lubricant adhesive to both contacting edges

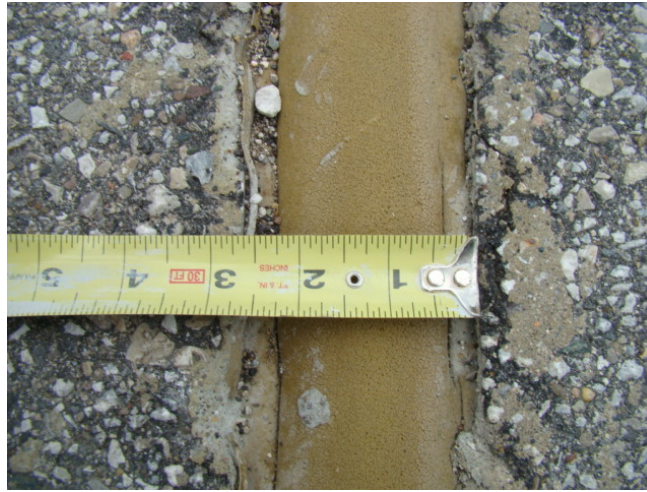
Once a PRJ has been installed work is not finished. It is very important for bridge inspectors to monitor the width of the joint and communicate to maintenance staff when a replacement is required. If the joint measures 1" to 2" a replacement should be added to the list of annual maintenance work crew recommendations. When a PRJ measures less than 1" it should be replaced immediately to eliminate the opportunity for damage.

Figure 36. Inspectors should measure the joint to prevent future damage

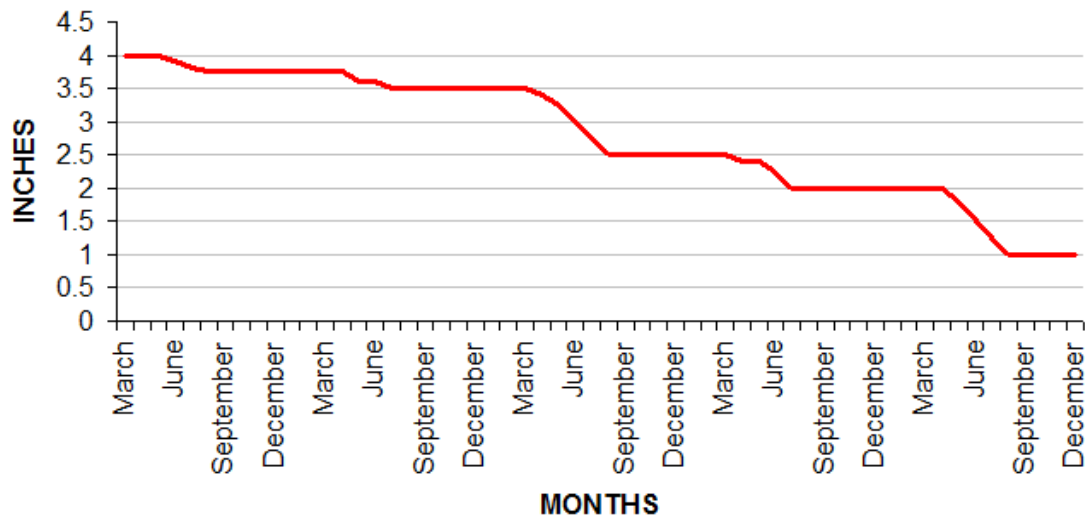
The amount of time required before performing a replacement will vary for each PRJ. A concrete repair project or bituminous overlay on the concrete roadway will significantly reduce the rate at which pavement stresses form. However, if no changes occur and the factors that cause PG are plentiful, replacements will often occur after only 4 years of service.

Figure 37. Characteristic monthly PRJ measurements
