Partial Depth Repair Keeps Highways and Urban Roads Intact

Patching Quickly Restores Damaged Areas In Concrete Pavement

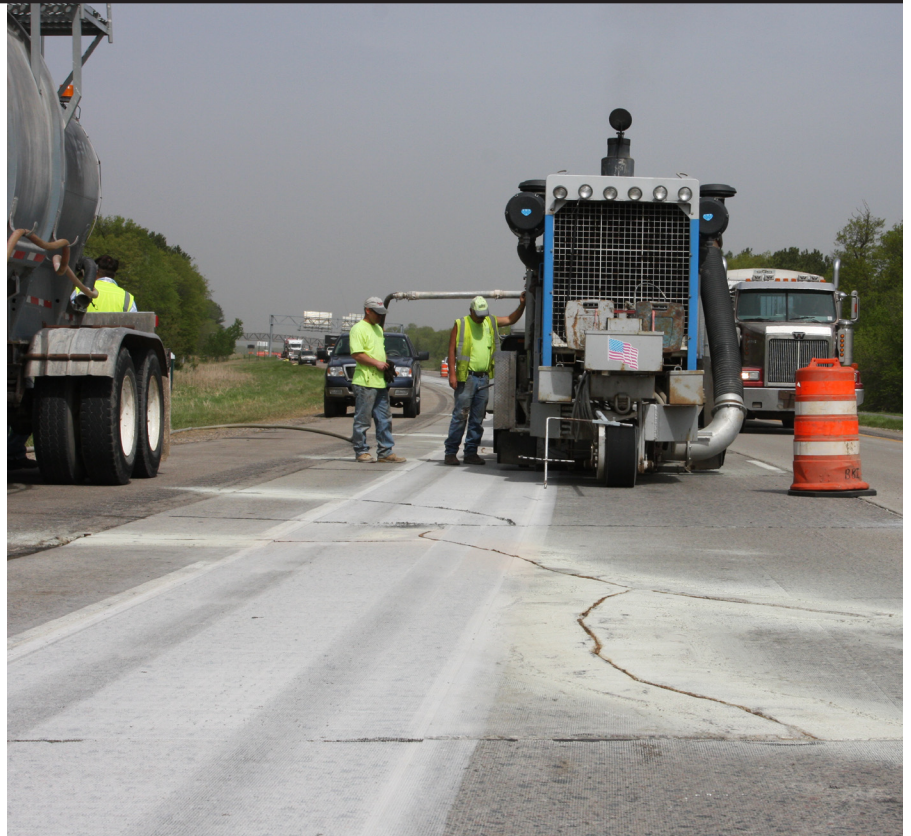
⚡ Complete PDR prior to diamond grinding

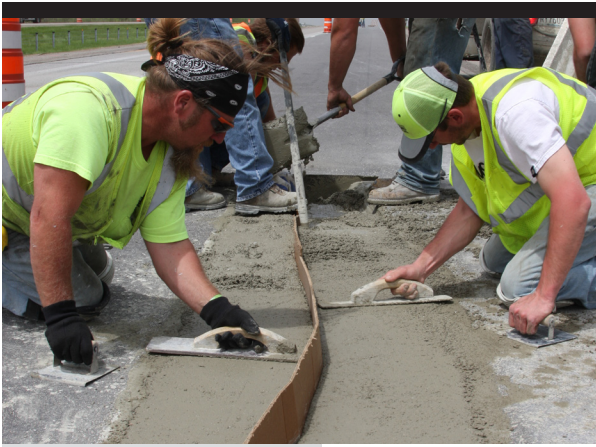
PDR concrete placement operation
