NASA TN D-4323

EFFECTS OF PAVEMENT TEXTURE ON  
WET-RUNWAY BRAKING PERFORMANCE

*by Trafford J. W. Leland, Thomas J. Yager,  
and Upshur T. Joyner*

*Langley Research Center  
Langley Station, Hampton, Va.*

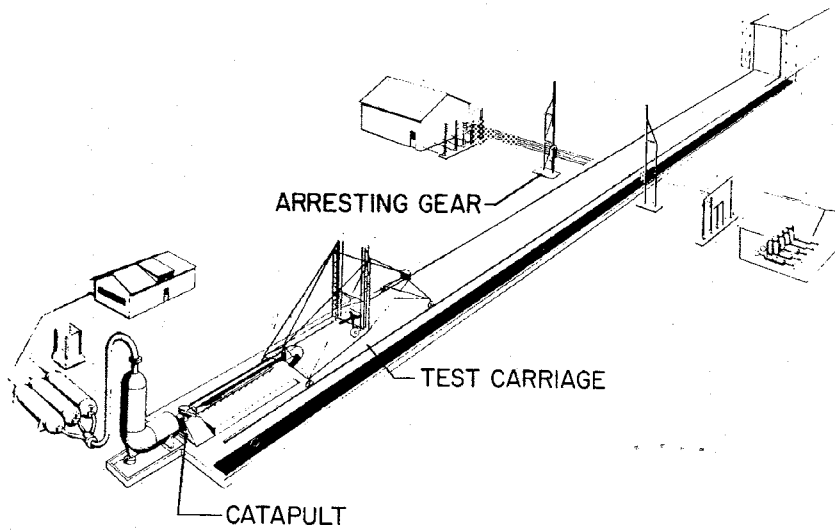
Figure 1.- Schematic of the Langley landing-load track.

The test program was conducted at the Langley landing-loads track, described in reference 2 and shown schematically in figure 1. The fixture for carrying the 32 × 8.8, type VII, aircraft tires used in the test is shown schematically in figure 2. As in previous

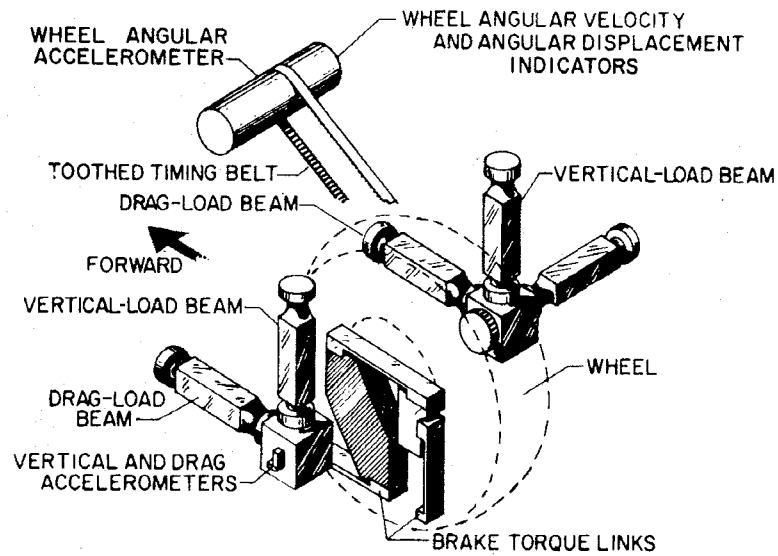
Figure 2.- Schematic of test fixture.

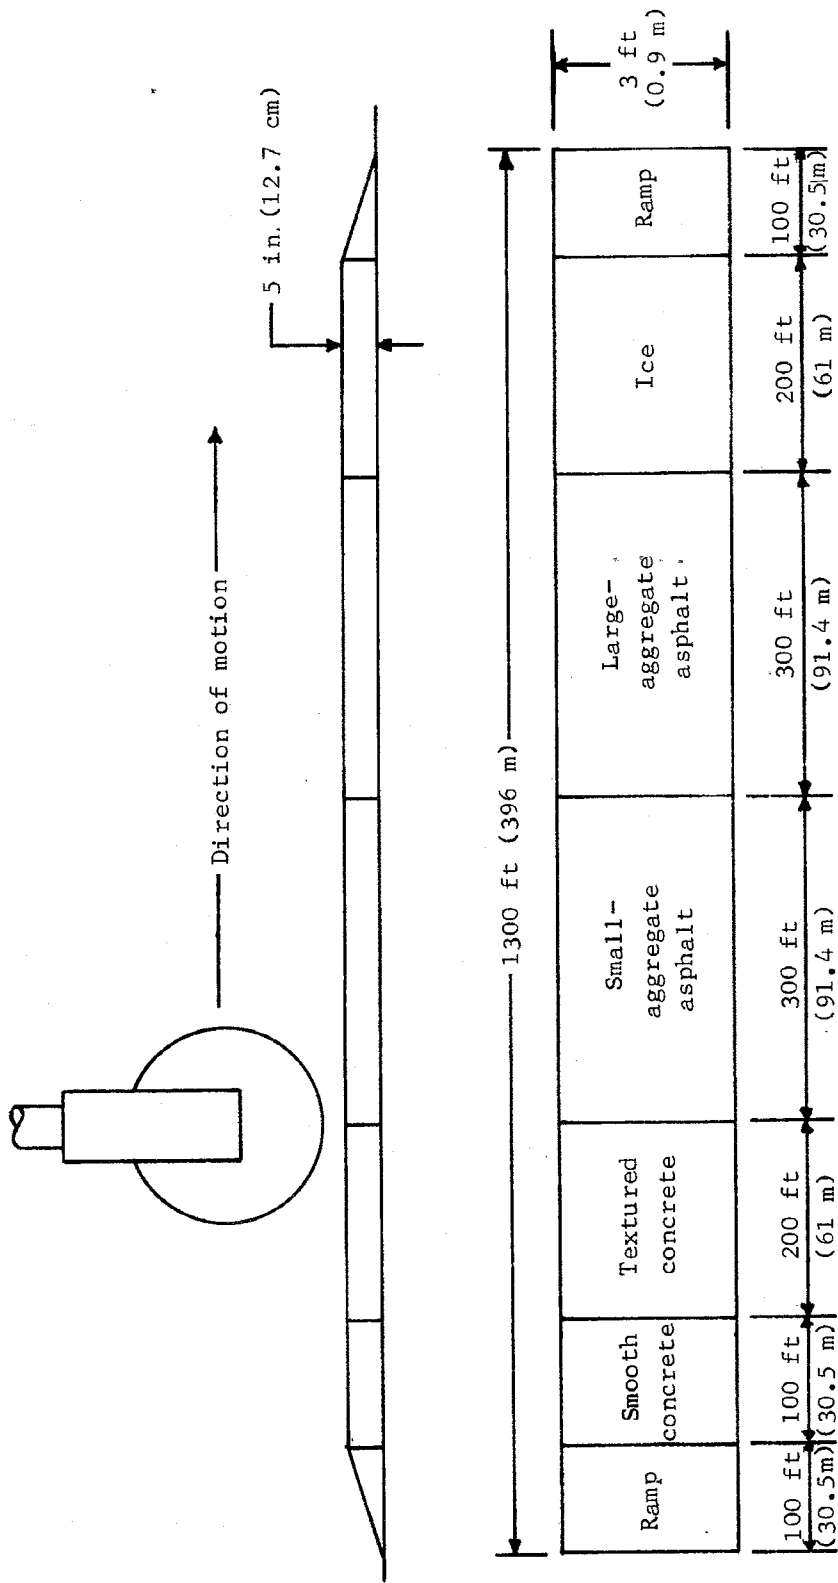
Figure 3.- Schematic of test section.

The test surface was arranged as shown schematically in figure 3 to provide a variety of runway surfaces ranging from very smooth to very rough. The surfaces are described as smooth concrete, textured concrete, small-aggregate asphalt, large-aggregate asphalt, and ice. Following wheel drop and spin-up on the 100-foot (30.5-meter) ramp, brake cycles were initiated on each test surface as the carriage proceeded down the track. The first braking surface (fig. 4(a)) was a very smooth, steel-trowel-finish concrete. The second surface (fig. 4(b)) was concrete which had been bag-dragged to provide a small-scale surface texture and was probably smoother than runway surfaces commonly in use today. The small-aggregate asphalt surface (fig. 4(c)) had an aggregate or stone size within accepted construction practices for runways today. The large-aggregate asphalt surface shown in figure 4(d) had an aggregate or stone size outside accepted runway practices, although the largest stone size did not exceed approximately 0.5 inch (1.3 cm). The ice surface shown in figure 4(e) was maintained by a refrigeration system which circulated brine through pipes located approximately 2 inches (5.1 cm) below the ice surface.

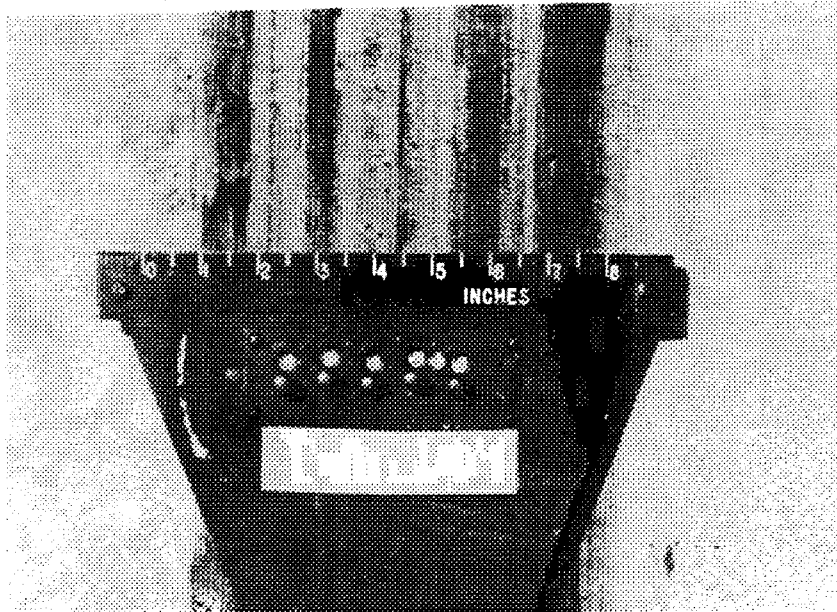
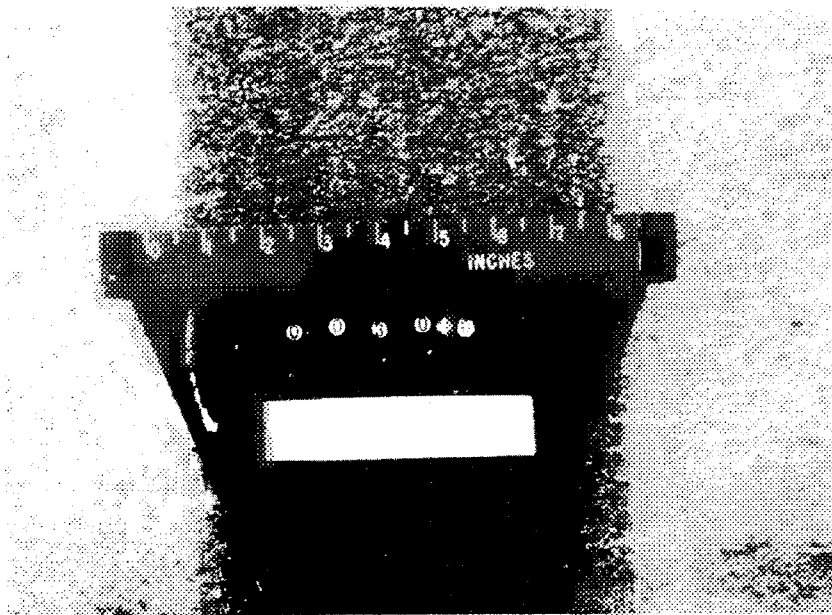
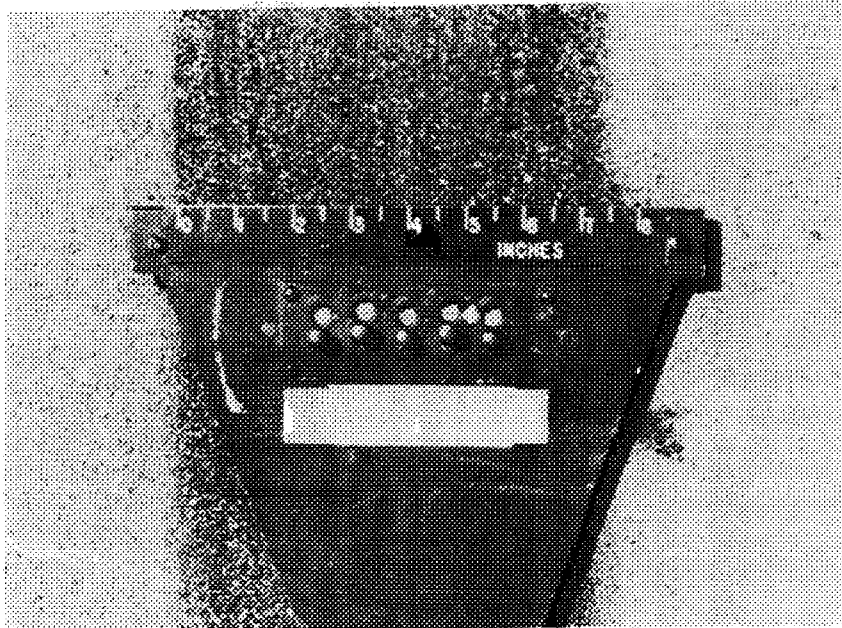
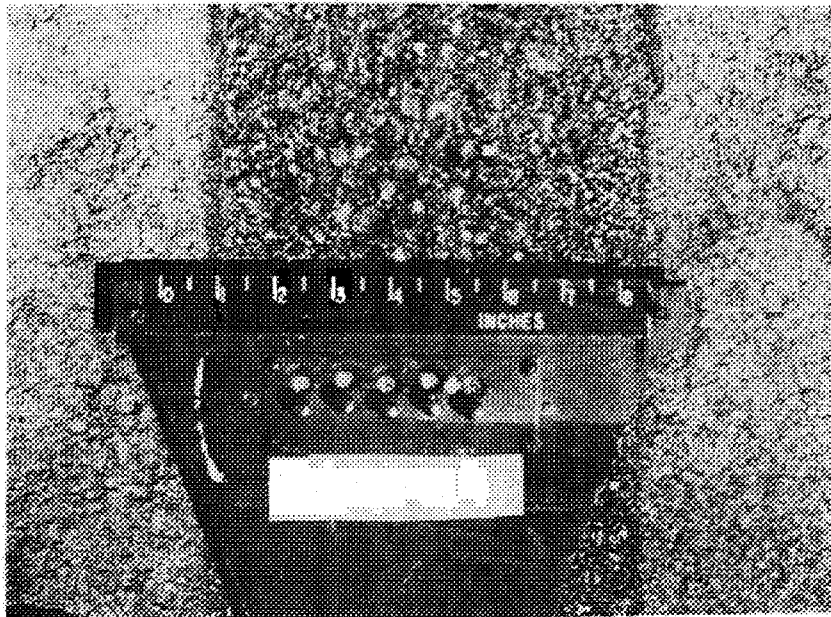
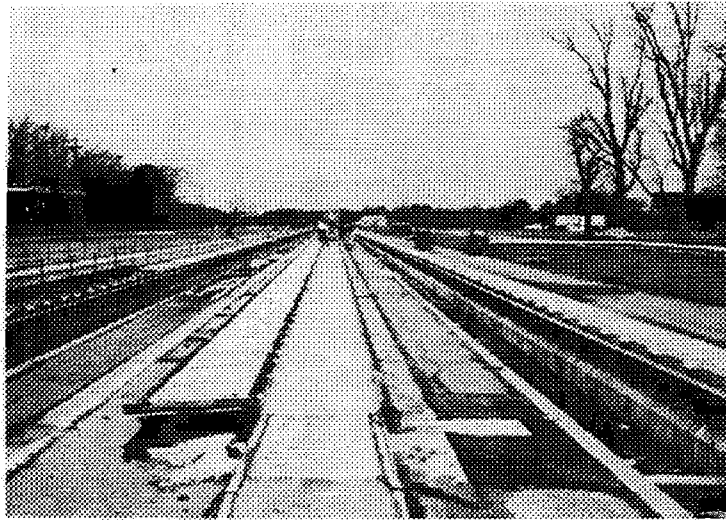
(a) Smooth concrete surface.

(b) Textured concrete surface.

Figure 4.- Photographs of test runway surfaces.

(c) Small-aggregate asphalt surface.

(d) Large-aggregate asphalt surface.

(e) Ice runway surface.

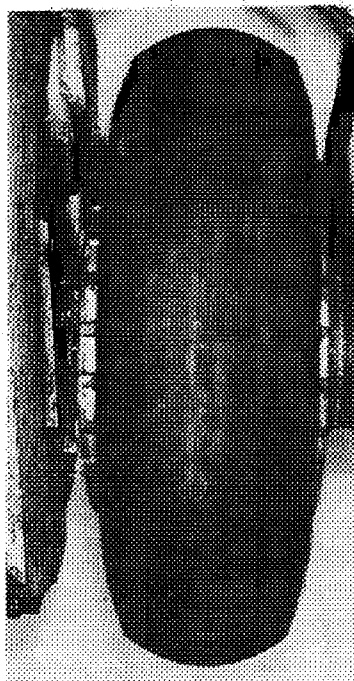
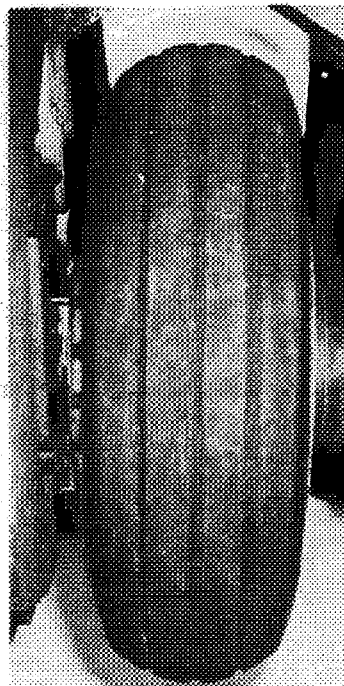
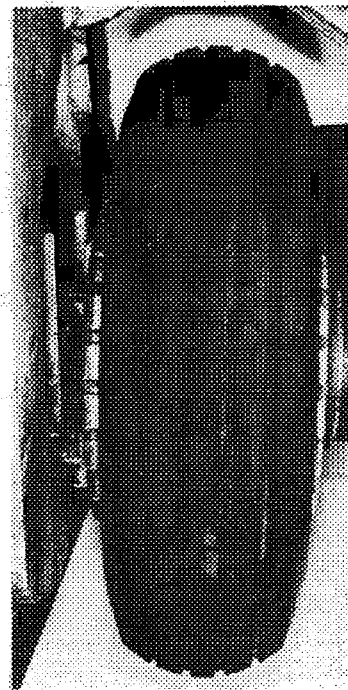
(a) Tire 1.

(b) Tire II.

(c) Tire III.

Figure 5.- Tires used in investigation.

The tires used were 32 x 8.8, type VII, 22-ply-rating, aircraft tires having the tread configurations shown in figure 5. The tires were specially molded for this test and had all-rubber treads (as opposed to fabric-reinforced treads) formed of a natural rubber compound. Tire I (fig. 5(a)) had a smooth tread whose thickness was equal to that of a new tire but had no tread pattern. Tire II (fig. 5(b)) had three equally spaced straight

circumferential grooves approximately 0.5 inch (1.3 cm) in width, and tire III (fig. 5(c)) had four similar 0.5-inch (1.3-cm) grooves.

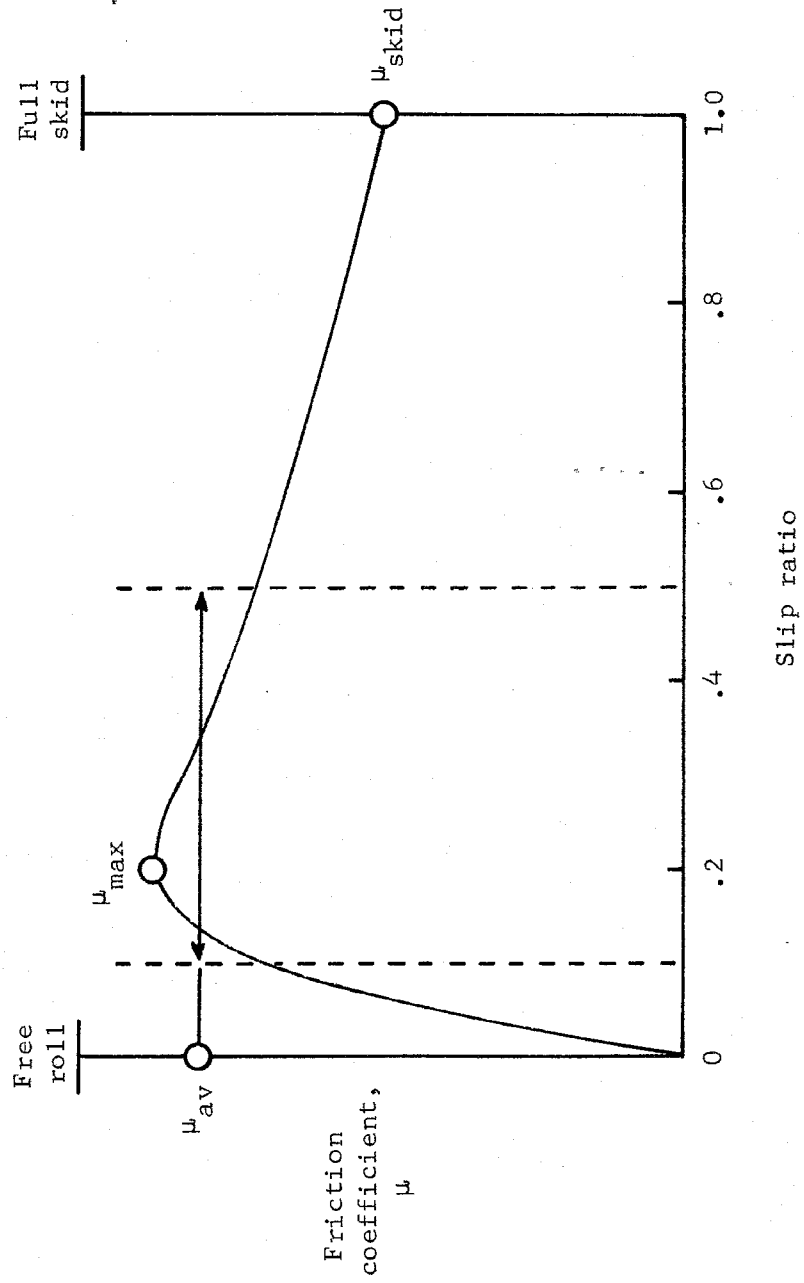
Figure 6.- Schematic comparison of various friction coefficients.

Instantaneous values of tire-ground friction coefficient  $\mu$  were plotted for each brake cycle from free roll (slip ratio of 0) to full skid (slip ratio of 1.0). The data presented will express braking friction coefficient in terms of the average tire-ground friction coefficient  $\mu_{av}$ , illustrated in figure 6. This parameter is defined as the average coefficient of friction obtained in the slip-ratio range of 0.1 to 0.5. Presenting the data in this manner tends to minimize the effects of localized differences in runway surface character covered during each brake cycle.

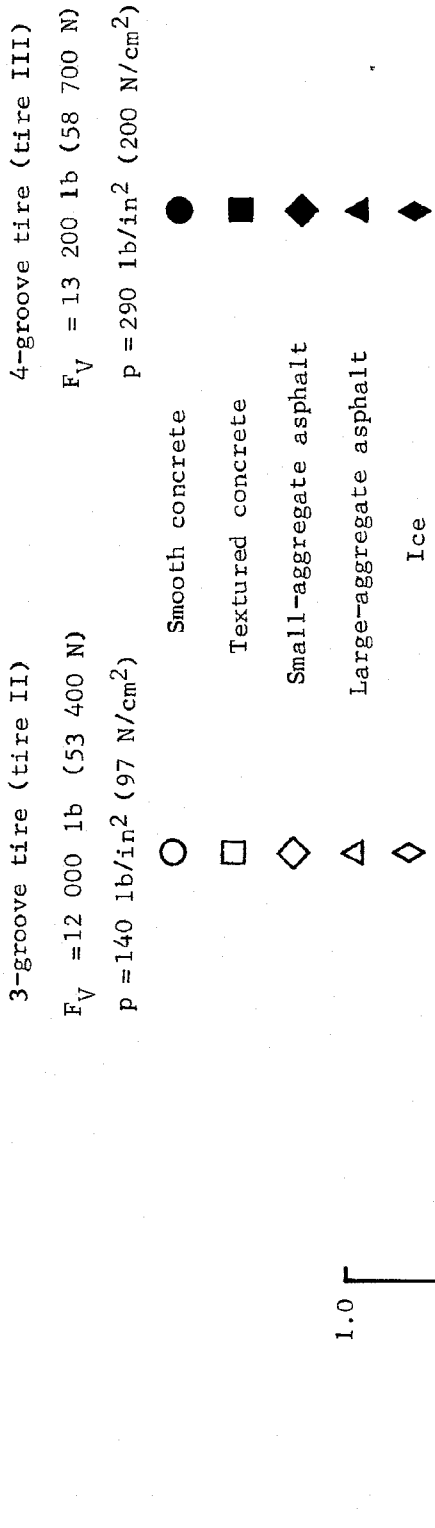
Figure 7.- Effect of surface texture and ground bearing pressure on dry-runway braking effectiveness for tires II and III.

The number of dry-runway braking runs was limited because of prohibitive tire wear and runway surface wear. The results of these dry-runway tests are presented in figure 7 for tires II and III braking on the five test surfaces described in the preceding section. The ice surface is not dry but is included for comparison, as is the dry-runway rolling-resistance curve obtained from reference 4 for a similar tire. Although tires II and III have different tread patterns, the results of reference 3 indicate that tread pattern has very little effect on dry-runway braking. Tire II, operating at a tire inflation pressure of 140 pounds per square inch (97 N/cm<sup>2</sup>) and vertical load of 12 000 pounds (53 400 N), developed significantly higher friction coefficients than did tire III operating at a tire inflation pressure of 290 pounds per square inch (200 N/cm<sup>2</sup>) and vertical load

of 13 200 pounds (58 700 N). This difference in friction coefficient agrees with previous work (ref. 5), which indicated that for dry-runway braking, the friction coefficient increased as tire pressure decreased, and is the effect of ground bearing pressure. Note that the ground bearing pressure for tire II is considerably lower than that for tire III.

No consistent variation of friction coefficient with variations in runway surface character seems to exist, with the exception of the smooth runway. These data points are in doubt, however, since the smooth surface was closest to the catapult, and at the higher speeds and/or with a following wind, this surface could easily have become contaminated with water sprayed from the jet catapult. Therefore, the lines shown in figure 7 were faired through the remaining test surfaces, and these lines will be used when other data are compared with dry-runway braking test results.

A definite ground bearing pressure effect was observed during braking on a dry runway (fig. 7) and the same bearing pressure effect can be noted when braking occurs on a flooded runway, as shown in figure 10. This figure compares the braking friction developed by the smooth tire (tire I) braking on three of the test surfaces at two conditions of vertical load and tire inflation pressure. At the lower speeds on the rougher surfaces, a ground bearing pressure effect similar to that shown in figure 7 can be noted with the lower pressure resulting in somewhat higher average friction coefficients. However, as forward speed is increased and fluid-density effects become predominant, a more rapid degradation in tire-ground friction can be noted for the lower tire inflation pressure as the predicted hydroplaning speed (ref. 1) is approached. Although the hydroplaning speed at the higher tire pressure is beyond the speed capability of the test carriage, the results in figure 10 indicate that large losses in braking friction coefficient can be delayed to a higher speed by increasing the tire inflation pressure, at the expense of somewhat lower friction levels at the lower speeds.

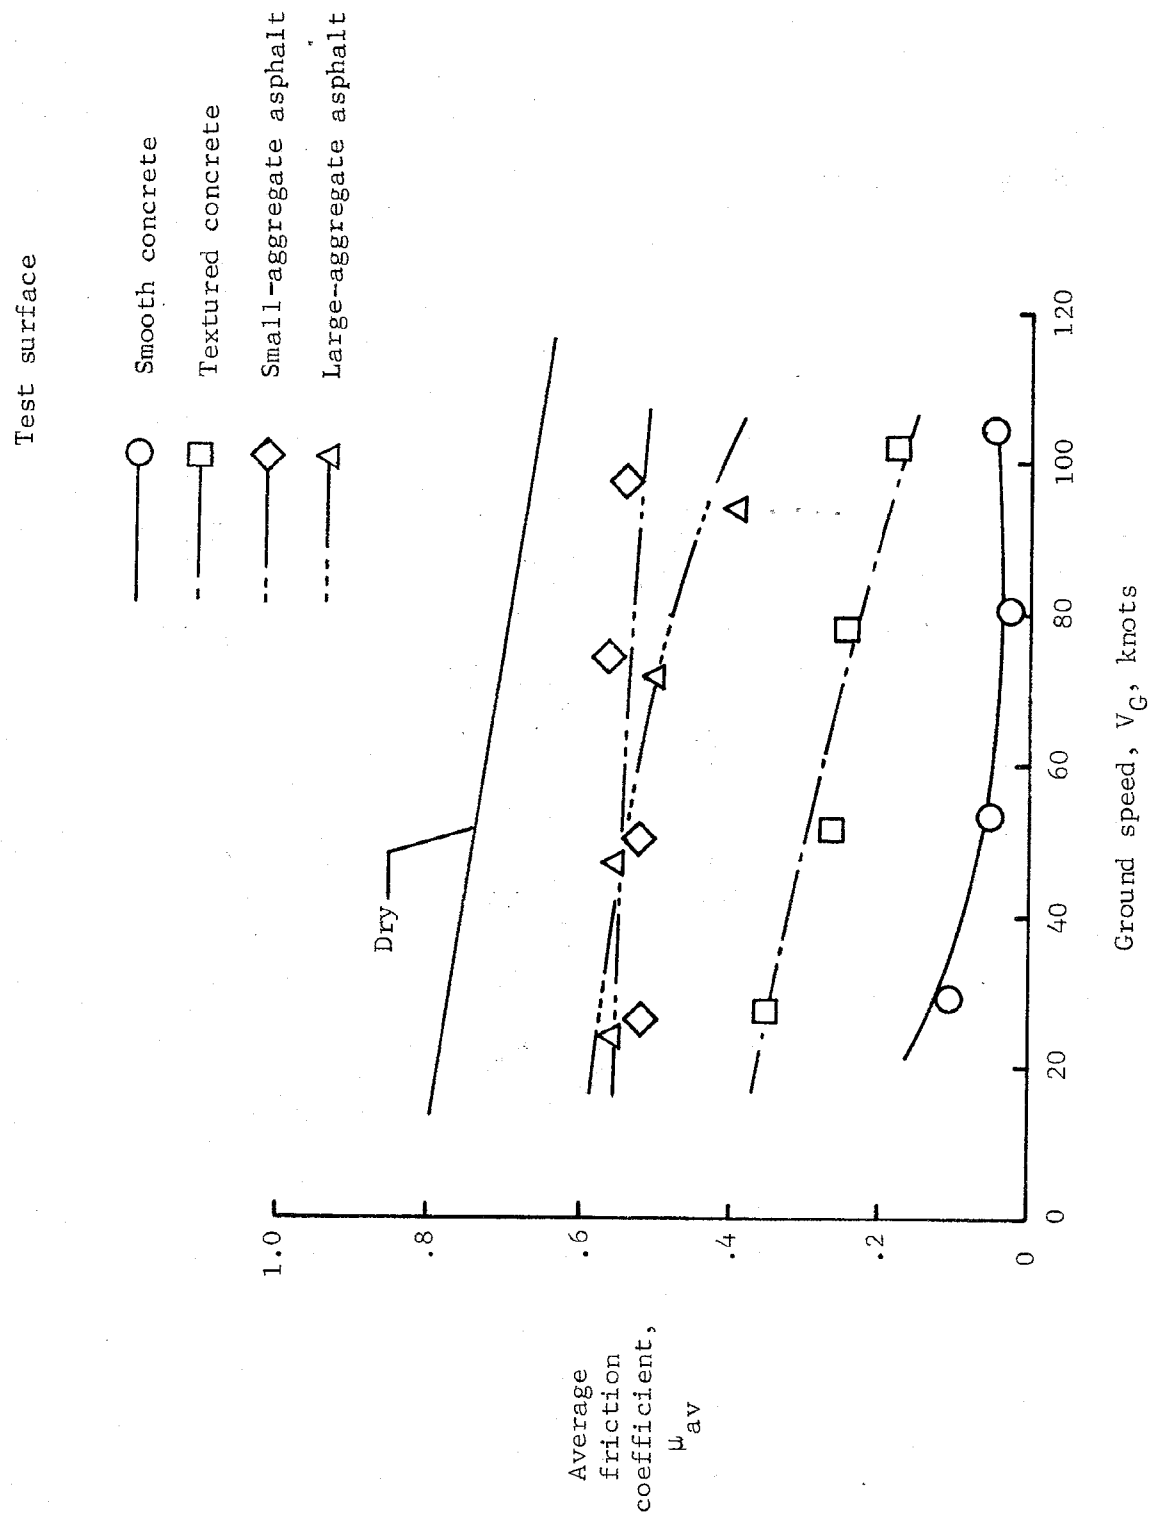
Figure 8.- Effect of surface texture on damp-runway braking effectiveness. Smooth tire (tire 1); vertical load,  $F_v = 12\ 000\ \text{lb}$  (53 400 N); tire inflation pressure,  $p = 140\ \text{lb/in}^2$  (97 N/cm<sup>2</sup>).

Although no significant differences in dry-runway braking friction coefficients were observed on the various textured test surfaces, figure 8 shows a pronounced surface texture effect and a large degradation in friction coefficient as a result of the addition of a small amount of water to the test surface. For this series of tests, a damp surface was obtained by wetting the entire surface until uniform discoloration was noted and then brushing out all standing water just prior to the run. The surface in this condition closely resembled a runway as it might look following a heavy dew. The smooth tire (tire I) used for this series was inflated to 140 pounds per square inch ( $97 \text{ N/cm}^2$ ) and carried a vertical load of 12 000 pounds (53 400 N).

When moisture is present, as shown in figure 8, surface character plays a significant role. Friction losses on the damp asphalt surfaces are on the order of 25 percent of the dry-surface values, but the smooth concrete reveals an almost total loss of available friction coefficient at the higher speeds (compare with the rolling-resistance coefficients shown in fig. 7). Since there was no standing water, it would seem that these large losses in braking effectiveness must be due to viscous, or lubricating-film, effect rather than a fluid-density effect. It is thought that the data in figure 8 show that a rougher textured surface tends to break up or penetrate through more of the fluid film than does a smooth surface because, in general, the friction coefficients shown are higher for the rougher surfaces.

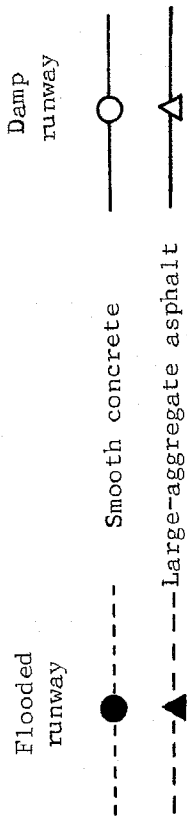
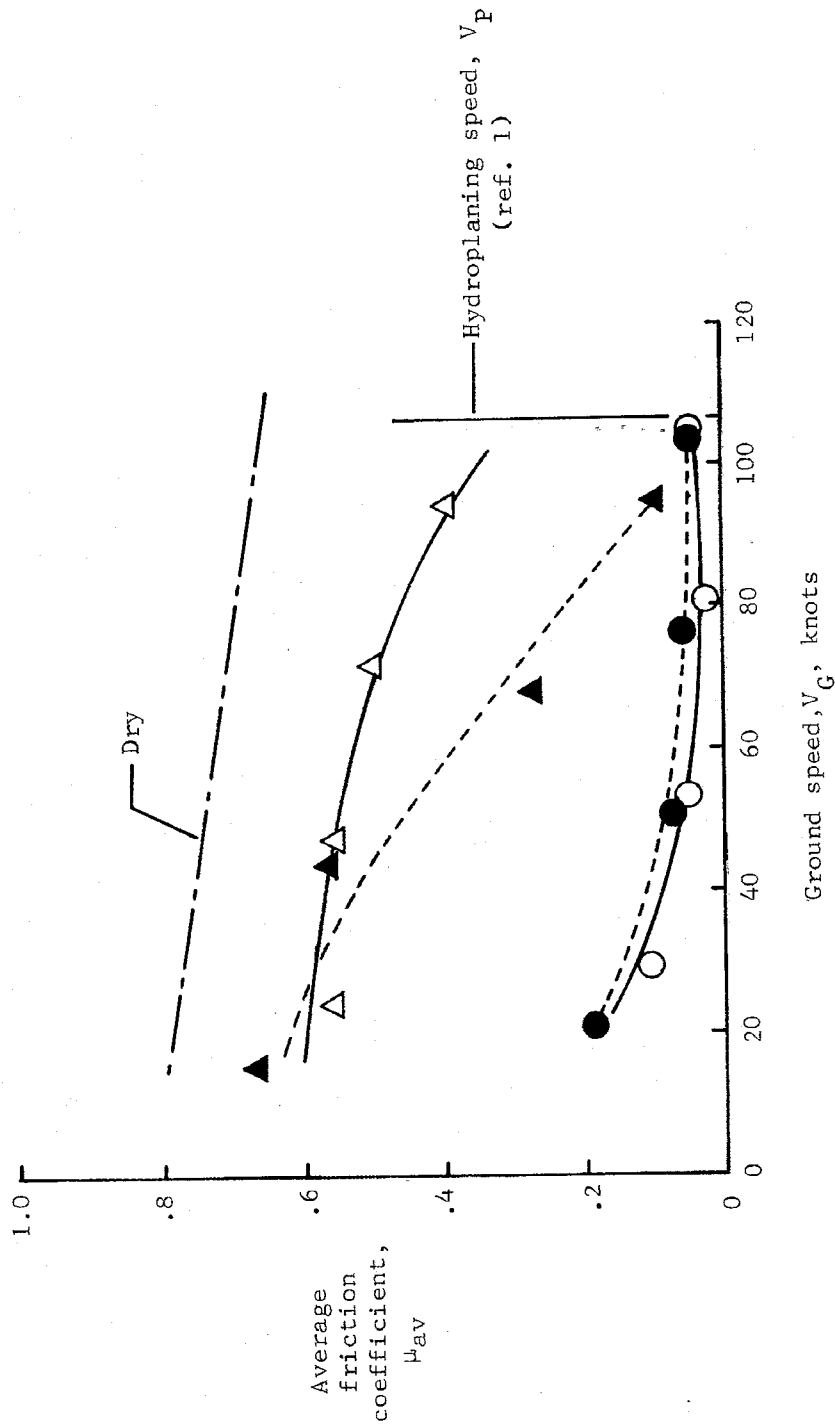
Figure 9.- Comparison of surface texture effects on damp and flooded runways. Flooded water depth = 0.1 to 0.2 inch (0.25 to 0.51 cm); smooth tire (tire D); vertical load,  $F_y = 12\ 000$  lb (53 400 N); tire inflation pressure,  $p = 140$  lb/in<sup>2</sup> (97 N/cm<sup>2</sup>).

The difference between the viscous effects noted in figure 8 and fluid-density effects, which occur in significant water depths, is shown in figure 9 in which the results of braking the smooth tire (tire I) on the smoothest and roughest test surfaces are compared for damp-runway and flooded-runway conditions. (The term "flooded" in this case means

that the water depth on the test surface varied from 0.1 to 0.2 inch (0.25 to 0.51 cm.) As shown in figure 9, at low speeds on the large-aggregate asphalt surface, there is little difference between the friction coefficient for the damp-runway and flooded-runway conditions. This fact indicates a predominant viscous fluid-film effect. As speed is increased, fluid-density effects increase and cause partial hydroplaning and a significant decrease in friction coefficient. Near the hydroplaning speed, as predicted by the method of reference 1, the available tire-ground friction drops to a very low value as the entire footprint area becomes supported by the water.

The smooth-concrete results in figure 9 show little significant difference with greater water depth and indicate that on this very smooth surface a slight amount of moisture provides a viscous film which remains unbroken by the smooth tire, so that the addition of more water causes very little change in friction coefficient.

and 140 test runs later, the smooth tire (tire I) was again tested at the smaller vertical load and tire pressure on flooded and damp surfaces as shown in figure 9. The difference in friction coefficient on the flooded surfaces in figures 9 and 10 is then due to pavement texture changes caused by traffic and weathering during the period between the two tests.

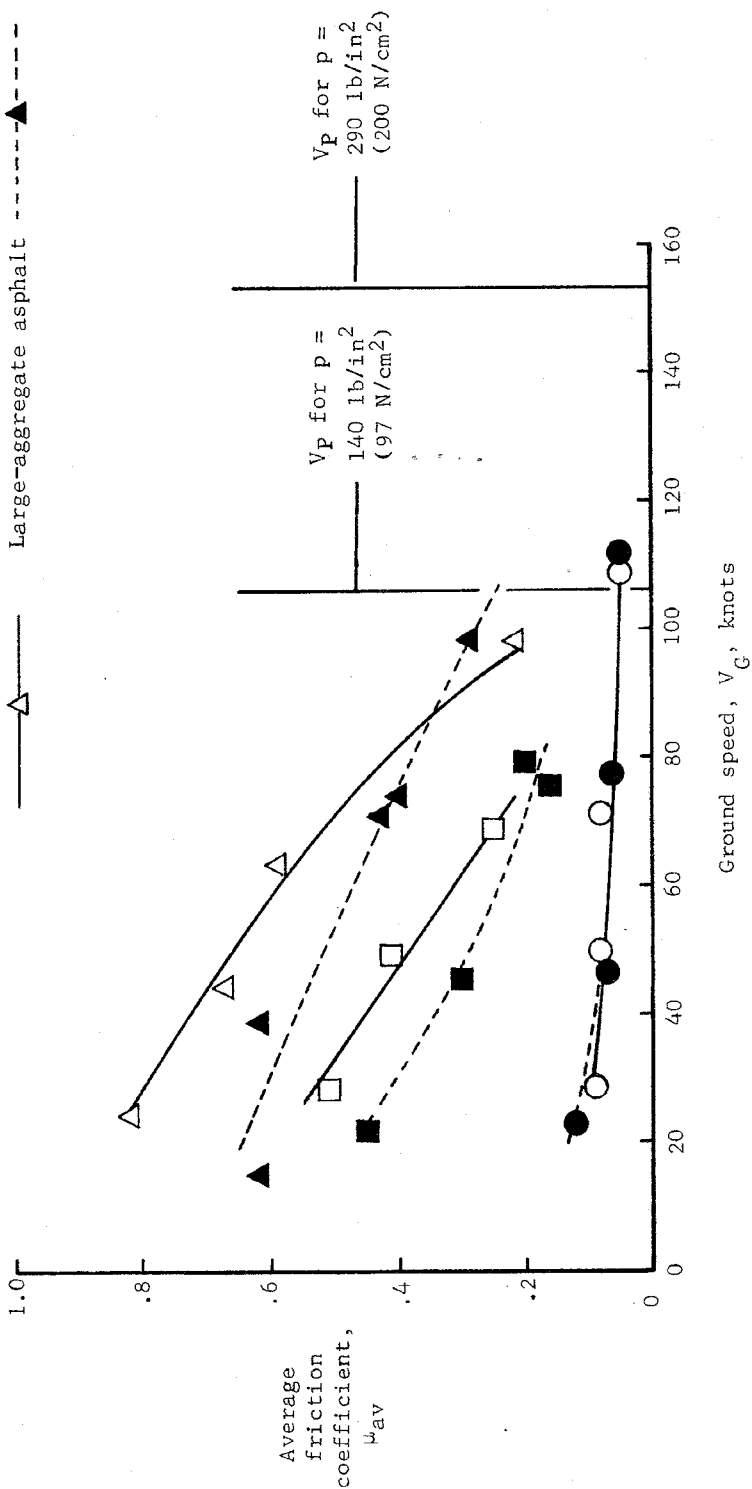
Figure 10.- Effect of ground bearing pressure on flooded-runway braking effectiveness for a smooth tire (tire 1). Water depth = 0.1 to 0.2 inch (0.25 to 0.51 cm).

Braking on the smooth concrete surface, as shown in figure 10, appears quite insensitive to ground bearing pressure. Thus, it can be inferred that the pressure necessary to break the viscous fluid film is considerably greater than any realistic value of tire inflation or ground bearing pressure. However, as indicated previously, this film may be broken by providing areas of extremely high local bearing pressure in the tire-ground contact region, such areas being provided by pavement texture, as discussed previously, by improved trend patterns or by pavement grooving.

The effect of pavement wear due to traffic and weathering is illustrated by comparing figures 9 and 10. In figure 10, the smooth tire (tire I) was tested on the flooded surfaces at the two conditions of vertical load and tire pressure shown. Three months

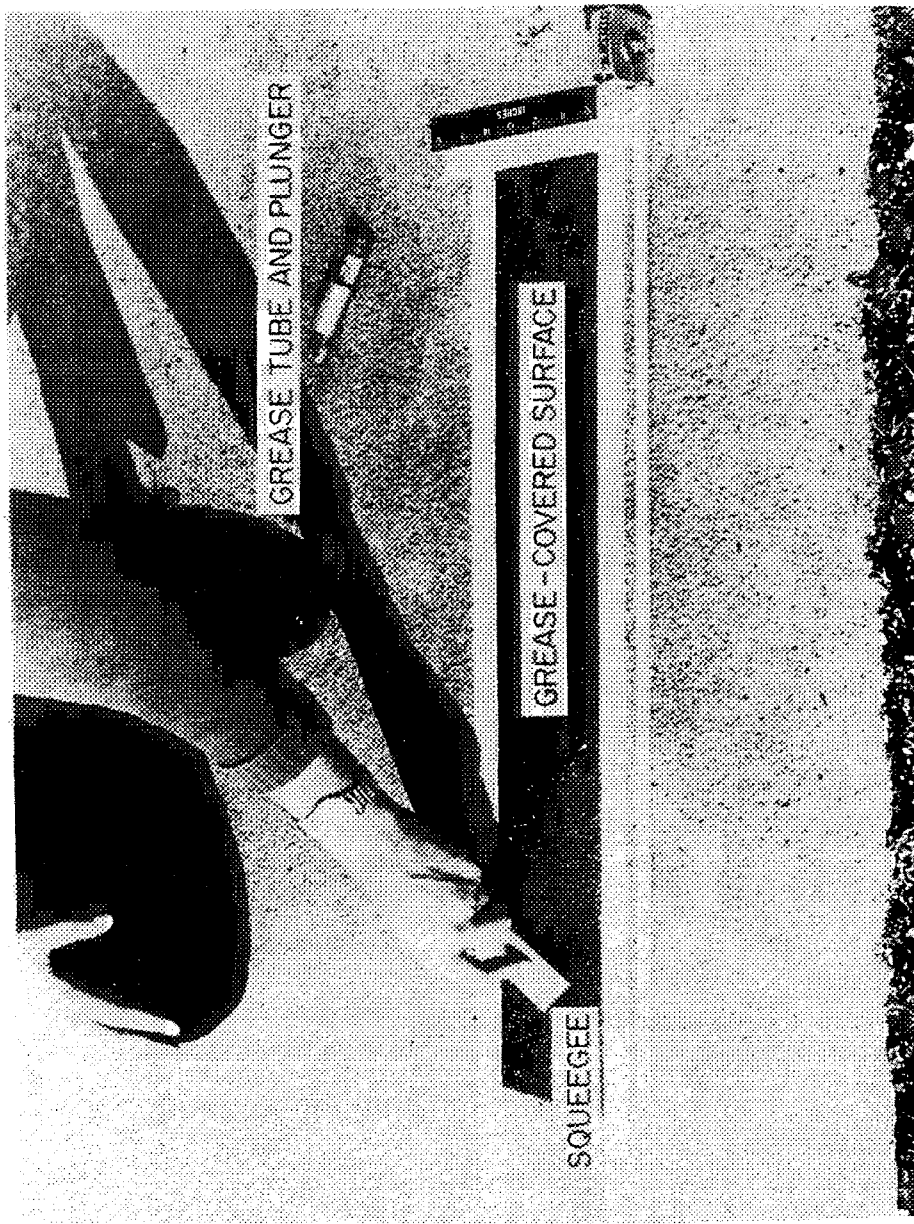
Figure 11.- Illustration of apparatus used in grease-application technique for measuring runway surface texture depth. L-67-6651

A photograph of a measurement being taken by the grease method of measuring runway or road roughness is presented in figure 11. The selected volume of grease has been worked into the voids in the runway surface, and the operator is again going over the surface with the rubber squeegee to be sure that no excess grease has been left. The technique shown has proved to be easy to apply and convenient for field applications.

Description of equipment. - The equipment required is limited to that shown in figures 11 and 16. On the left of figure 16 is shown the tube which is used to measure the selected volume of grease. On the right is shown the tight-fitting plunger which is used to expel the grease from the tube, and in the center is shown the rubber squeegee which is used to work the grease into the voids in the runway or road surface. The sheet rubber of the squeegee was cemented to a piece of aluminum for ease in use. The grease used was a general purpose lubricant. At this time it is thought that any general purpose grease can be used.

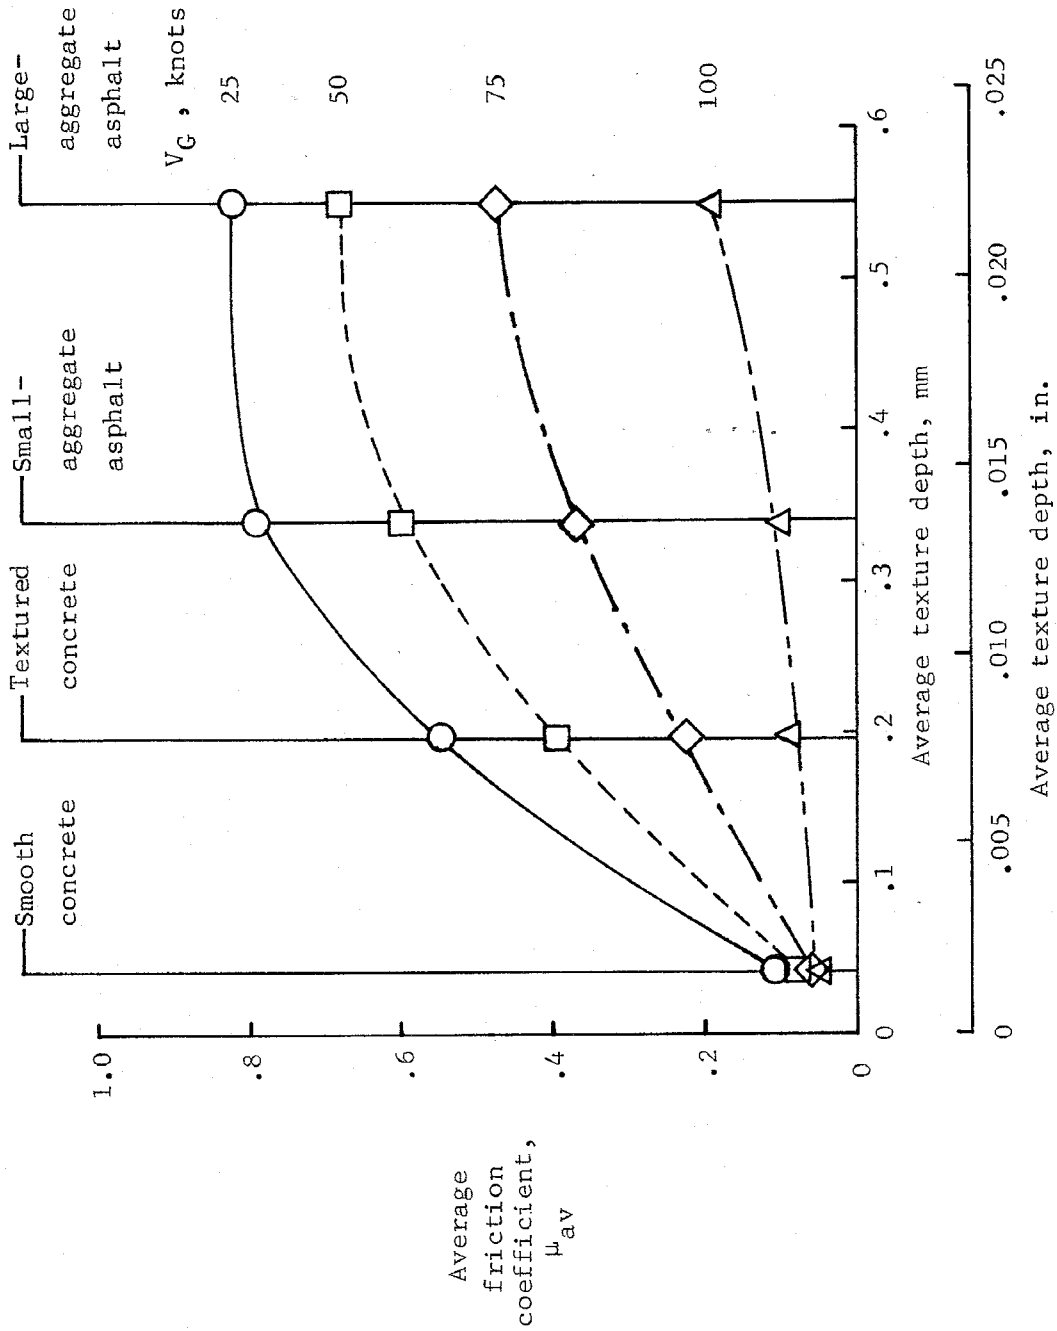
Figure 12.- Effect of measured surface roughness on average friction coefficient developed on a flooded runway. Smooth tire (tire I); vertical load,  $F_V = 12\ 000\ \text{lb}$  (53 400 N); tire inflation pressure,  $p = 140\ \text{lb/in}^2$  (97 N/cm<sup>2</sup>); water depth = 0.1 to 0.2 inch (0.25 to 0.51 cm).

The method previously described should, for most reliable results, be statistical in nature with many different samples being taken of the surface. However, the limited length of the test sections used in this investigation made it possible to take only one sample on each of the four surfaces. The results were most encouraging, as shown in figure 12 in which the average friction coefficient developed on a flooded surface by the smooth tire at four forward speeds is plotted against the average texture depth for the four surfaces investigated. Increasing texture depth, or surface roughness, is seen to improve tire-ground friction at all speeds tested, and at the lower speeds, a friction level which is nearly equal to the dry-runway friction coefficients shown in figure 7 is reached. This effect probably accounts for the leveling off of the curve near the roughness level of the small-aggregate asphalt surface and suggests some speed-dependent limiting value of surface roughness beyond which no great improvement in braking can be realized, and the rougher surface might well increase tire wear.

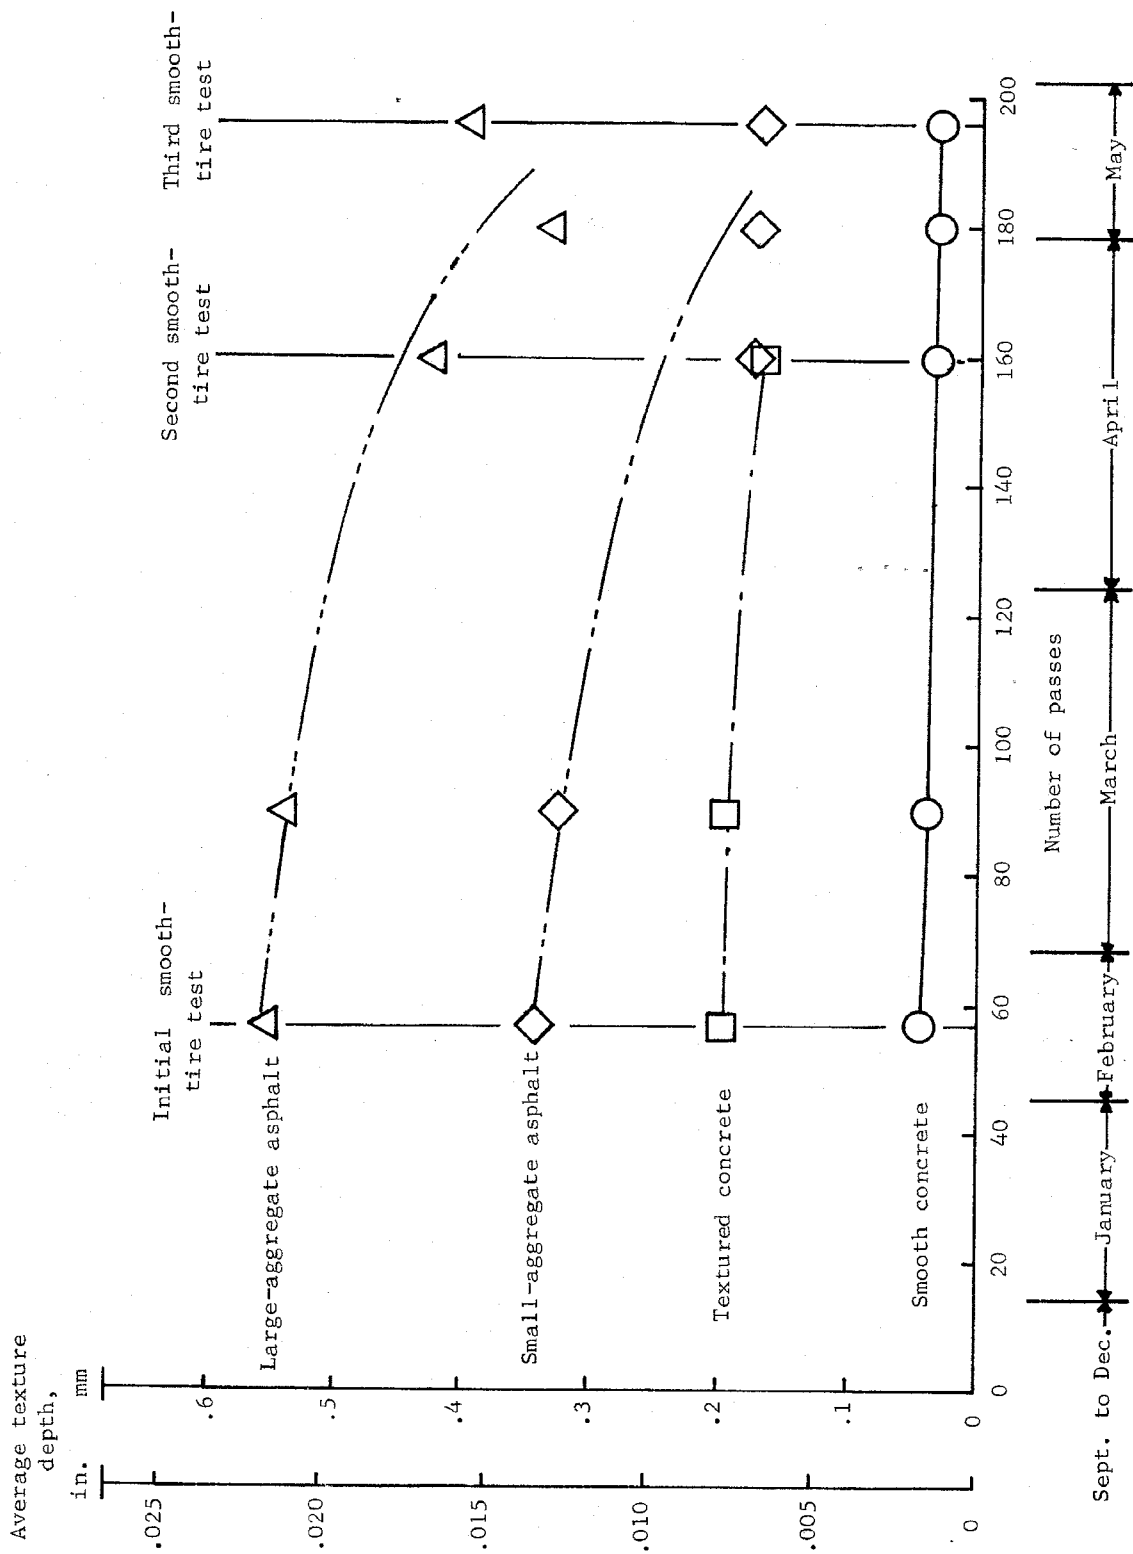
Figure 13.- Experimental measurements of surface wear during the test program.

The correlation of friction coefficients with surface measurements obtained by the grease technique was made coincidental with the first series of runs on the smooth control tire (tire I). The results of this correlation were so encouraging that the method was applied at intervals throughout the remainder of the testing period. The construction of the test carriage and fixture (figs. 1 and 2) constrained the test tire to the same path for each run. Thus, the traffic over the test section can be evaluated quite closely and is summarized in table I. The results of the continuing surface-texture studies are shown in figure 13 in which the average texture depths as measured by the grease technique for the four surfaces are plotted against the total number of passes made over each surface prior to the measurement. Although there is some scattering of data in figure 13, probably due to the restricted number of samples, a change in surface character is noted for the three rougher surfaces and little change is noted for the smooth concrete surface. This surface change is taken to be a deterioration of the surface, since the average texture depth is becoming smaller. The surface change undoubtedly arises from a combination of traffic and weathering, and although the two effects cannot at this time be separated, a time scale is included at the bottom of figure 13 for reference.

The smooth control tire (tire I) was tested at approximately the intervals shown by the vertical lines in figure 13. In figure 14, the average friction coefficient developed by the smooth tire on each of the four test surfaces at four nominal forward velocities shows how the measured surface wear affected the braking friction levels attained by this tire. At the higher speeds, the large-aggregate asphalt surface (fig. 14(a)) showed the greatest degradation in braking friction coefficient, and as shown in figure 13, this surface also experienced the greatest change in surface character. The small-aggregate asphalt (fig. 14(b)) and the textured concrete (fig. 14(c)) show similar trends and again the trends are reflected by the surface-wear measurements shown in figure 13.
