NASA TN D-4323

EFFECTS OF PAVEMENT TEXTURE ON  
WET-RUNWAY BRAKING PERFORMANCE

*by Trafford J. W. Leland, Thomas J. Yager,  
and Upshur T. Joyner*

*Langley Research Center  
Langley Station, Hampton, Va.*

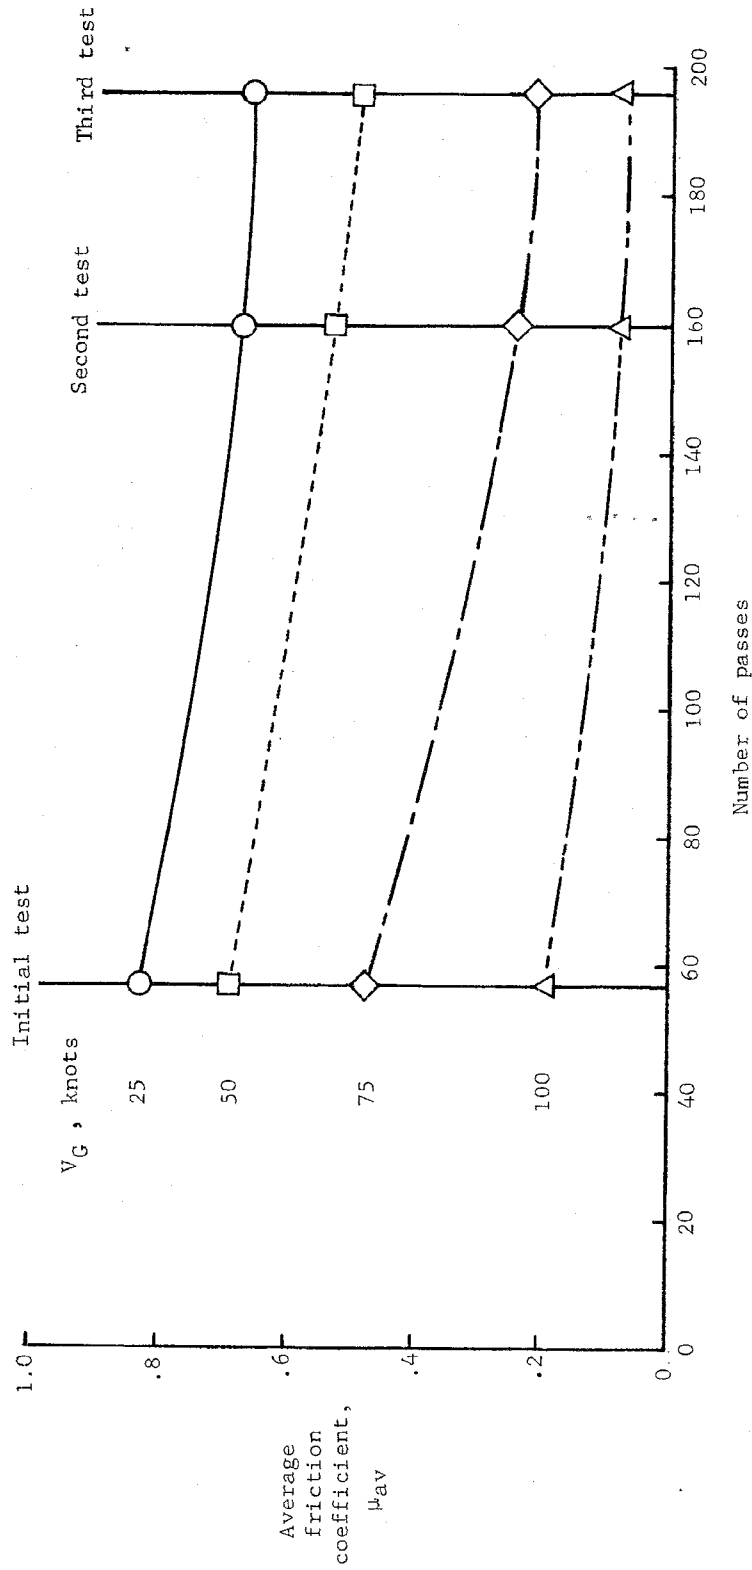
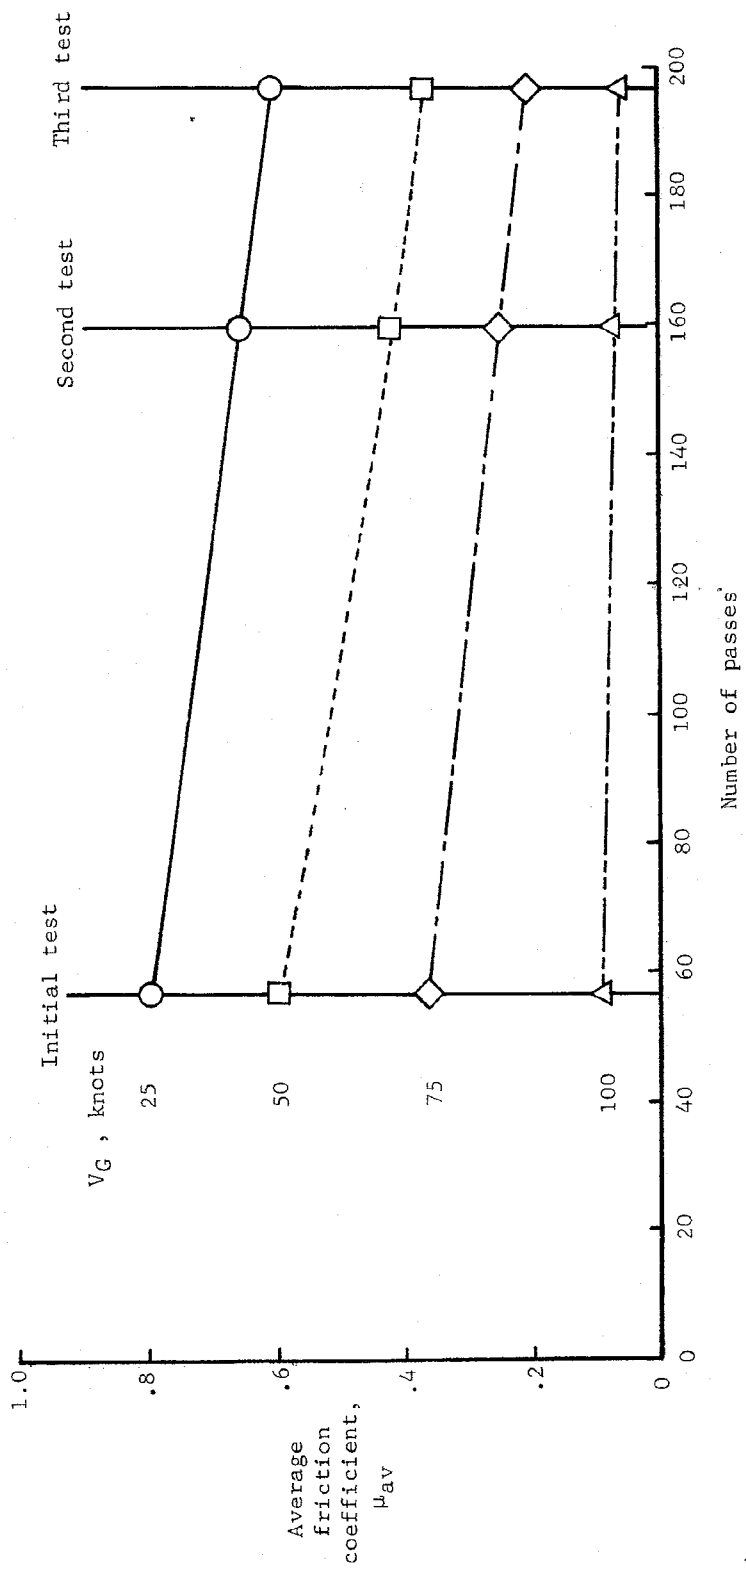
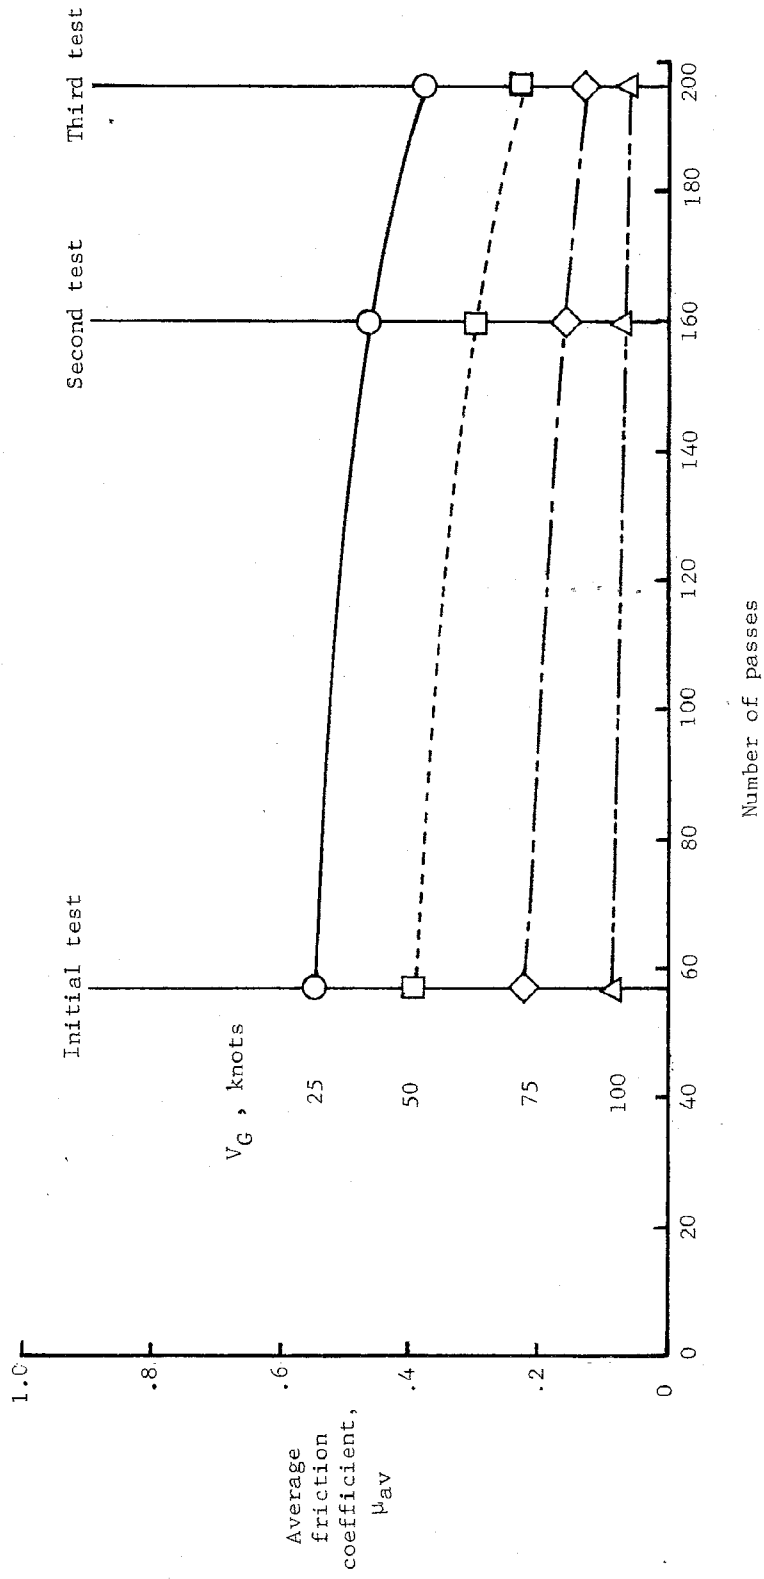
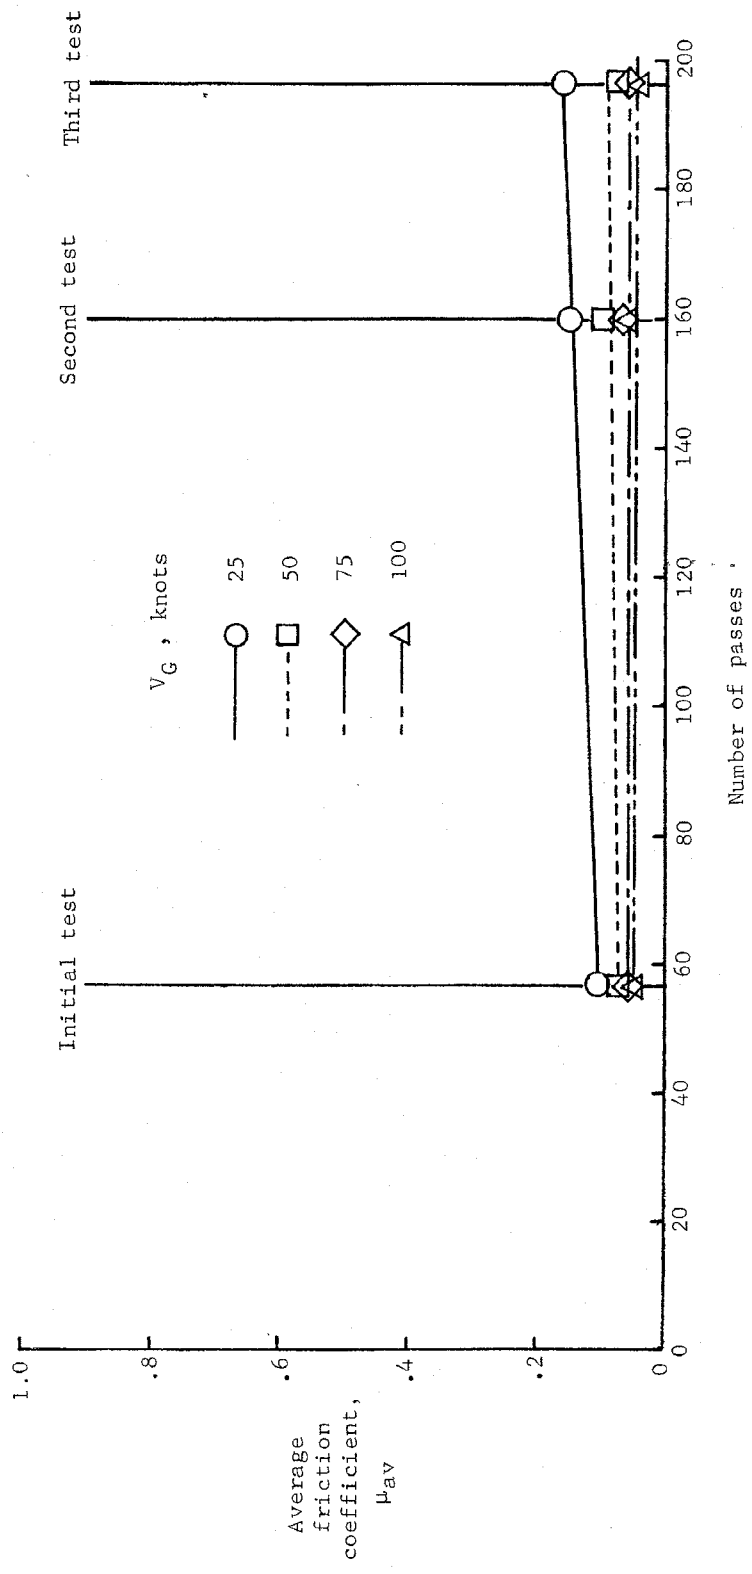
(a) Large-aggregate asphalt surface.

Figure 14.- Effect of surface wear on the friction coefficient developed on the four surfaces tested. Smooth tire (tire 1); vertical load,  $F_v = 12\ 000$  lb (53 400 N); tire inflation pressure,  $p = 140$  lb/in<sup>2</sup> (97 N/cm<sup>2</sup>); water depth = 0.1 to 0.2 inch (0.25 to 0.51 cm).

(b) Small-aggregate asphalt surface.

(c) Textured concrete surface.

(d) Smooth concrete surface.

The smooth control tire (tire I) was tested at approximately the intervals shown by the vertical lines in figure 13. In figure 14, the average friction coefficient developed by the smooth tire on each of the four test surfaces at four nominal forward velocities shows how the measured surface wear affected the braking friction levels attained by this tire. At the higher speeds, the large-aggregate asphalt surface (fig. 14(a)) showed the greatest degradation in braking friction coefficient, and as shown in figure 13, this surface also experienced the greatest change in surface character. The small-aggregate asphalt (fig. 14(b)) and the textured concrete (fig. 14(c)) show similar trends and again the trends are reflected by the surface-wear measurements shown in figure 13.

The smooth concrete, shown in figure 14(d), exhibits somewhat different characteristics in that the friction coefficient tends to increase slightly with increasing surface wear, although little change was noted in the smooth concrete surface-texture measurements of figure 13. This increase is thought to be due to the peculiar way in which the smooth concrete surface weathered. The surface of the concrete developed hairline cracks resembling, in the final stages, a mosaic pattern. It is believed that the viscosity of the grease used in the texture measurements made the measurements insensitive to these cracks but that the cracks did offer a small measure of relief to the water trapped between the tire and the ground and, thus, improved the friction coefficient.

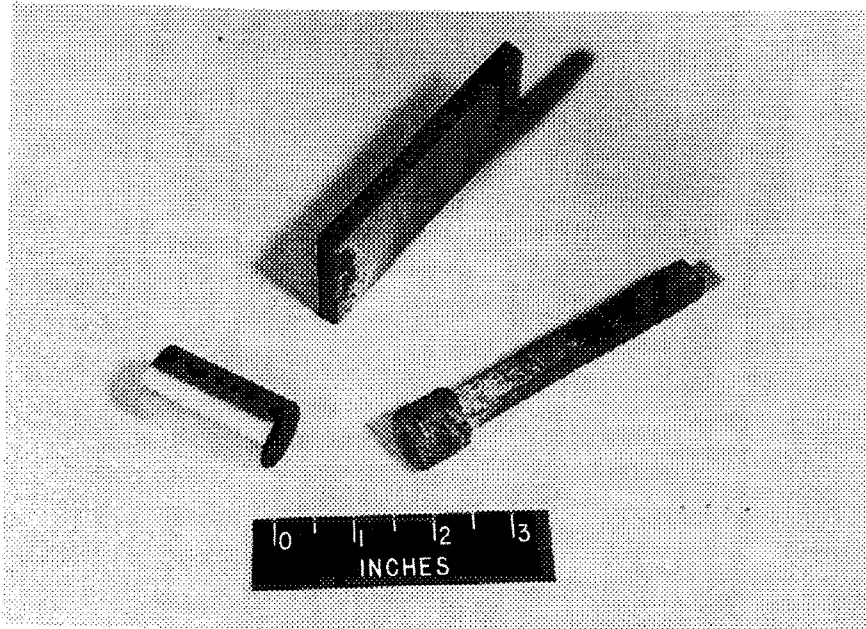
Figure 16.- Grease-volume measuring tube, plunger, and rubber squeegee. L-65-1868

Description of equipment. - The equipment required is limited to that shown in figures 11 and 16. On the left of figure 16 is shown the tube which is used to measure the selected volume of grease. On the right is shown the tight-fitting plunger which is used to expel the grease from the tube, and in the center is shown the rubber squeegee which is used to work the grease into the voids in the runway or road surface. The sheet rubber of the squeegee was cemented to a piece of aluminum for ease in use. The grease used was a general purpose lubricant. At this time it is thought that any general purpose grease can be used.

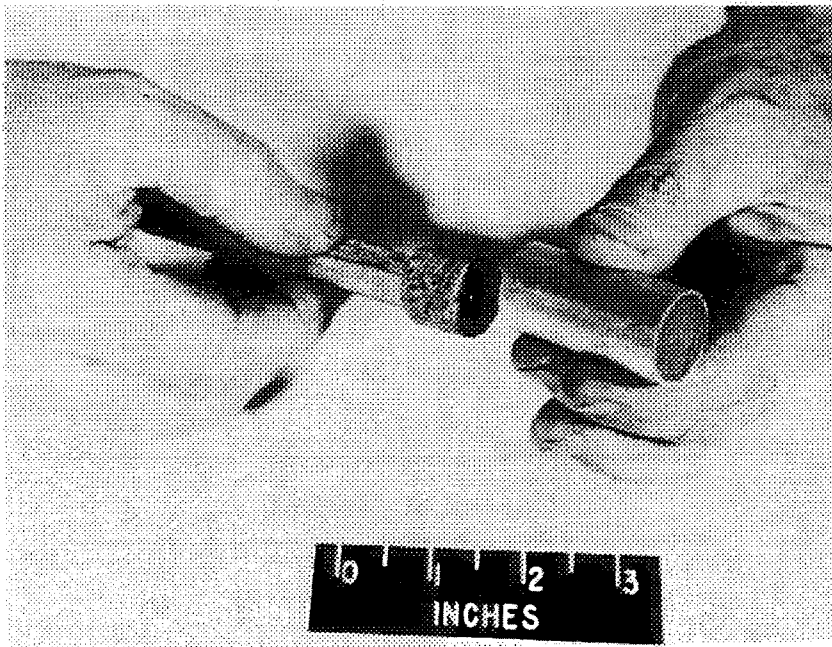
Figure 17.- Measuring tube filled with grease. L-65-1869

Use of equipment. - The tube for measuring the selected volume of grease is packed full with a tool like a putty knife in such a way as to avoid entrapped air, and the ends are squared off as shown in figure 17. The grease is then expelled from the measuring tube with the plunger and deposited between previously placed lines of masking tape. It is then worked into the voids of the runway surface with the rubber squeegee. Care is taken that no grease is left on the masking tape or on the squeegee. Measurements are then taken, the area is computed, and the roughness in millimeters is obtained by use of either equation (A1) or equation (A2).

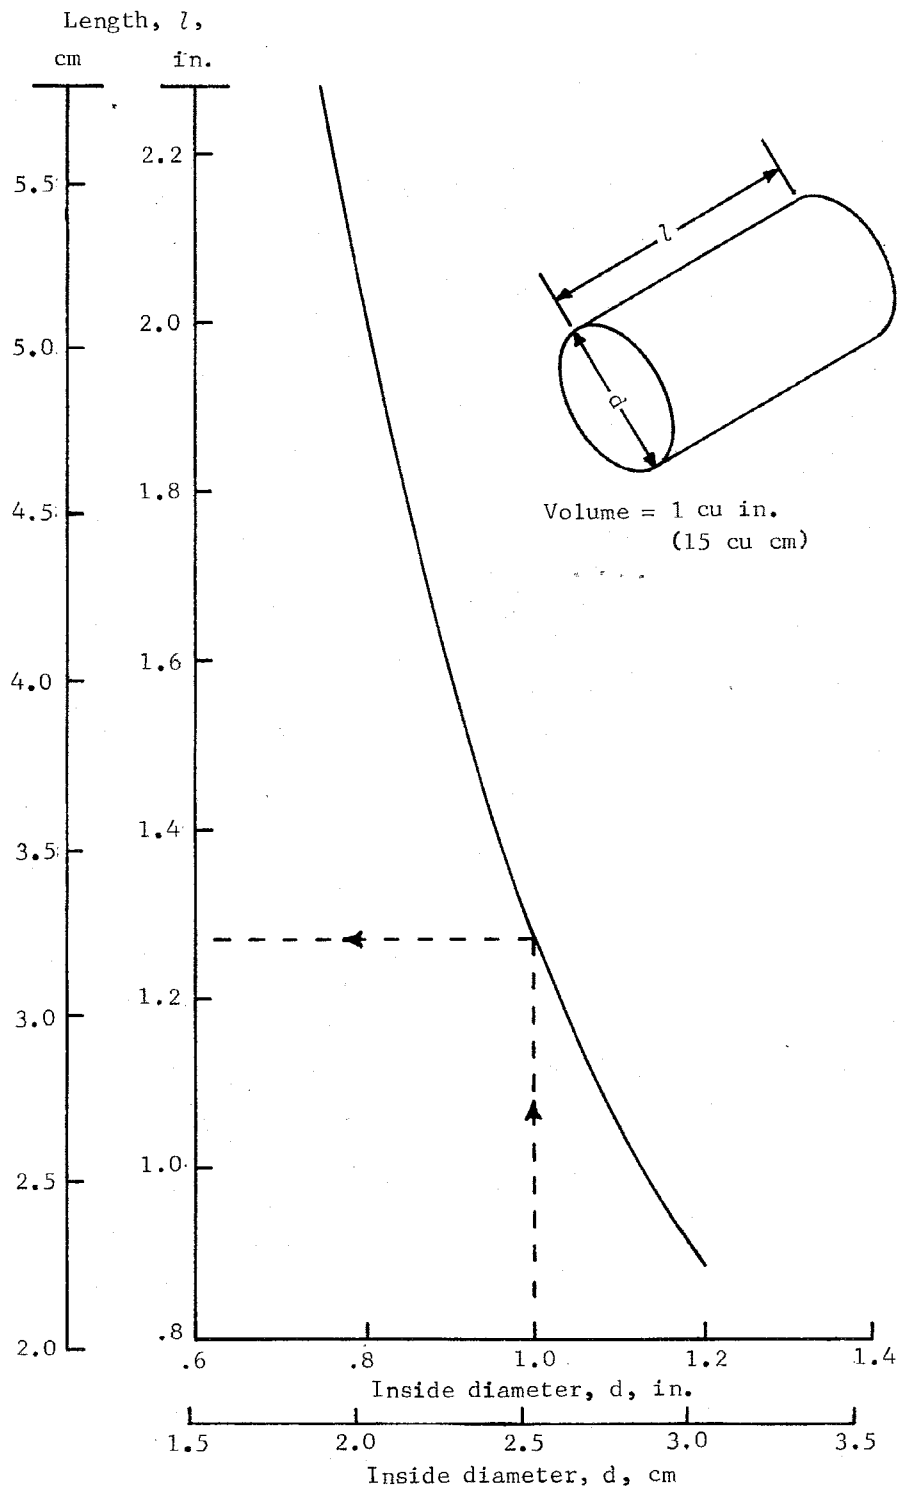
Figure 18.- Measuring-tube dimensions to measure 1 cubic inch or 15 cubic centimeters of grease.

Selection of measuring tube. - As a convenience in the selection of the length of the measuring tube, figure 18 gives the relation between the tube inside diameter and tube length for an internal tube volume of 1 cubic inch or 15 cubic centimeters. The plunger can be made of cork, rubber, or other resilient material to achieve a tight fit in the measuring tube.
