CPR: BUILT TO LAST

Barlow Road & Gateway Avenue Rehabilitation, Fort Morgan, CO

>>> PAVEMENT REHABILITATION - SLAB STABILIZATION, JOINT SEALING AND DIAMOND GRINDING

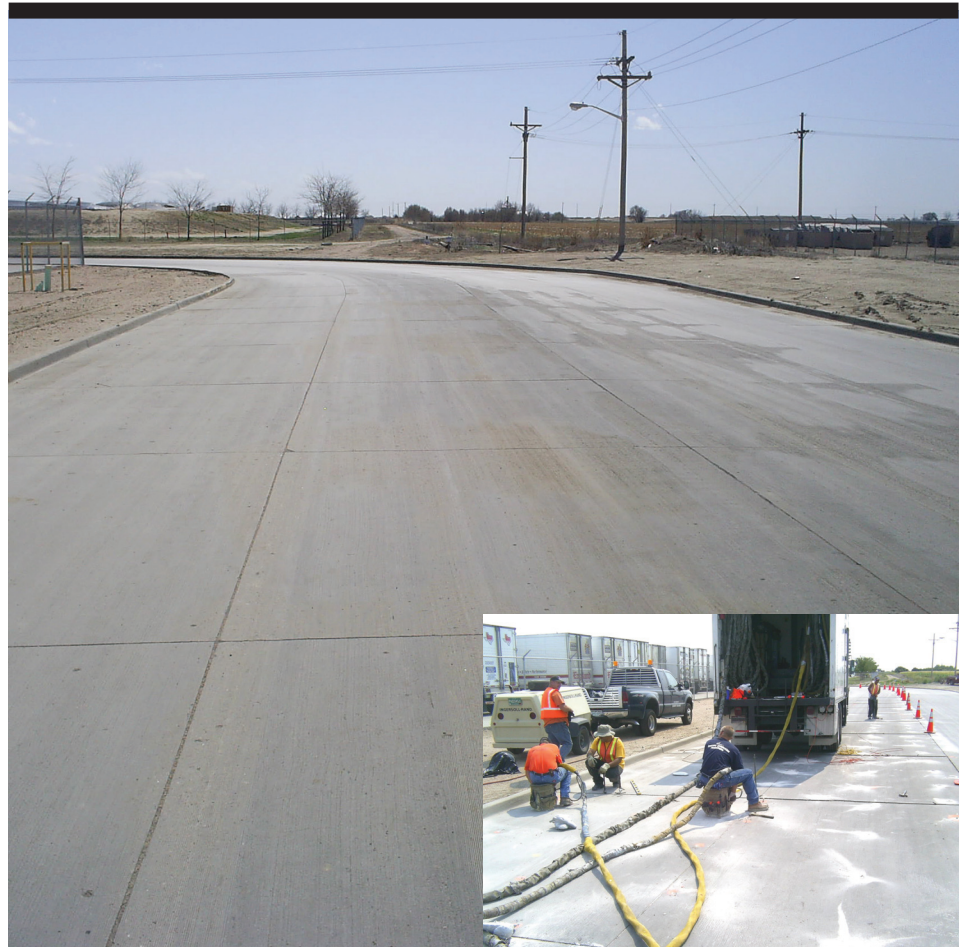
BORDERING THE EASTERN and southern sides of the Cargill Meat Solutions Plant in Fort Morgan, Colorado, Barlow Road and Gateway Avenue serve as the only route for continual 24-hour heavy truck traffic to move cattle and product to and from the plant. Because of the high level of wear developed over the years, a one-mile long, four-lane-wide, segment of this roadway was in need of repairs. Nearly all of the road panels experienced faulting in both travel directions at an average panel displacement of 3/8-1/2 inches. As a result, the bumpy riding surface was in need of rehabilitation.

The heart of the problem existed within the design, which did not incorporate dowel bars at the transverse joints and instead relied on base layers and aggregate interlock for load transfer. Unfortunately this design was no match for the extreme truck loading that this pavement received on a daily basis. The solution sub-surface rehabilitation of the non-reinforced concrete pavement in the form of base and sub-base stabilization, under sealing and alignment/lifting of concrete panels, diamond grinding and joint sealing. Each panel was lifted and leveled with the adjacent panel at the transverse joint by drilling a pattern of 5/8-inch holes on 4-foot spacing through the pavement. Next, an expanding structural polymer from Uretek USA was injected to lift and stabilize the surface. Diamond grinding was performed to smooth transverse joints and remove panel warping. The final stepped included sealing approximately 35,000 linear feet of joints.

Deep sub-surface voids under pavement corners and joints in areas of utility cuts required deep stabilization, which posed a challenge on this project. These weak sub-grade areas were treated and stabilized without removal of any pavement, using the Uretek USA technology. In addition, seasonal temperatures delayed some of the joint sealing and tighter joints were difficult to lift and align.

The non-destructive methods used on this project eliminated the need to tear out the existing pavement, which saved time and money. By closing only one lane at a time, the roadway was able to safely remain open full time to local traffic with all lanes available for use between project work shifts.
